APPENDIX M CASE 10-T-0139 WATERBODY INVENTORY (114A) & WETLAND DELINEATION REPORT

Wetland & Waterbodies Delineation Report

Champlain Hudson Power Express Segment 9 - Package 5B

Bethlehem, New York

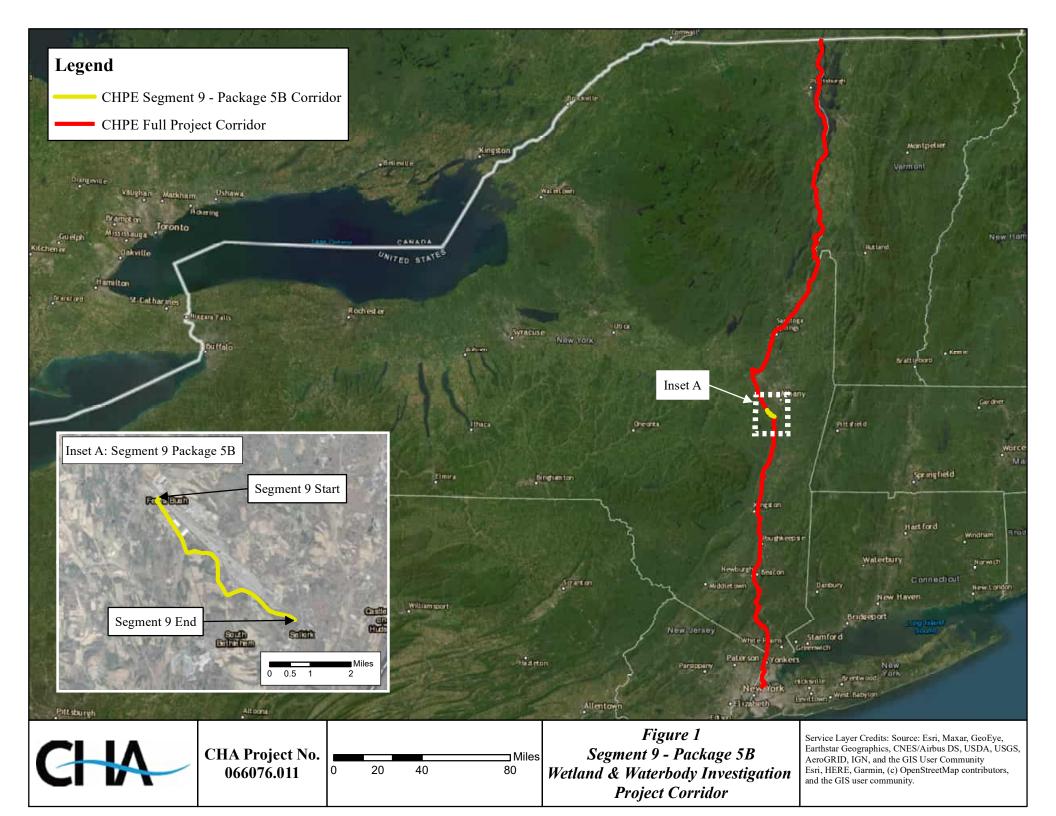
The entire Project Corridor is approximately 339 miles from Montreal, Quebec, Canada to New York City, New York, USA. Figure 1 below shows the route from the Canadian border to New York City and highlights the approximately 5.3 miles of the Segment 9 - Package 5B Project Corridor that was investigated for wetlands and waterbodies.

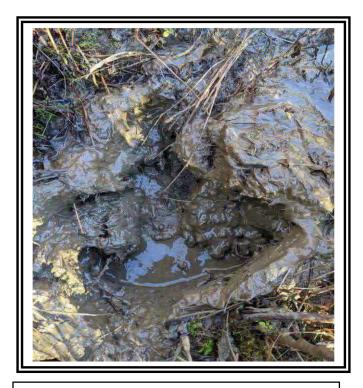
Wetland 12.14 A- Soils

Profile Desc	cription: (Describe	to the dep	oth needed to docu	ment the i	ndicator	or confirn	n the absence	of indicators.)	
Depth	Matrix		Redo	ox Features	5				
(inches)	Color (moist)	%	Color (moist)	%	Type ¹	_Loc ²	Texture	Remarks	
0-16	10yr/2/1	9 5	10yr/4/6	5	- 🔻		SaLo	Prominent	
	10917271		10917470			<u> </u> ∐-	3820	Tromment	
					▼

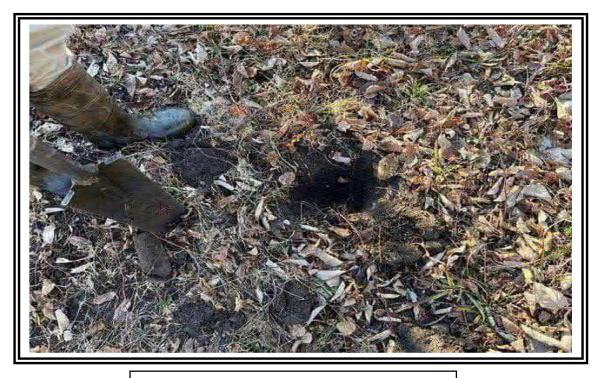
Upland 12.14 A- Soils

Depth	Matrix			k Featu				
(inches)	Color (moist)	%	Color (moist)	%	Type ¹	Loc ²	Texture	Remarks
0-16	10yr 4/1						Loamy/Clayey	
						·	<u> </u>	
,								
·						<u> </u>		
·								
<u> </u>								
·						·		
·								
¹ Type: C=Cor	ncentration, D=Depl	etion, RM	I=Reduced Matrix, M	1S=Mas	ked Sand	d Grains.	² Location: F	PL=Pore Lining, M=Matrix.
Hydric Soil In	ndicators:						Indicators	for Problematic Hydric Soils ³ :
Histosol (A	A1)		Polyvalue Belo	w Surfa	ice (S8) (I	_RR R,	2 cm M	uck (A10) (LRR K, L, MLRA 149B)
Histic Epip	pedon (A2)		MLRA 149B)			Coast F	Prairie Redox (A16) (LRR K, L, R)
Black Hist			Thin Dark Surfa					ucky Peat or Peat (S3) (LRR K, L, R)
	Sulfide (A4)		High Chroma S					ue Below Surface (S8) (LRR K, L)
	Layers (A5)		Loamy Mucky			R K, L)		ark Surface (S9) (LRR K , L)
	Below Dark Surface	e (A11)	Loamy Gleyed		(F2)			inganese Masses (F12) (LRR K, L, R)
	k Surface (A12)		Depleted Matrix					nt Floodplain Soils (F19) (MLRA 149

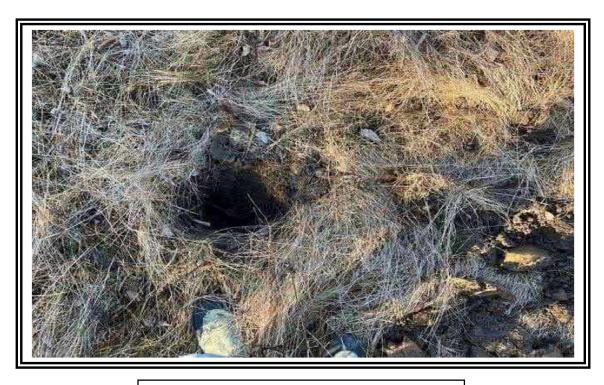
Upland 12.14 B- Soils

to the de	-			ator or co	onfirm the absence of	f indicators.)	
Depth	Matrix			x Featu			_	_	
(inches)	Color (moist)	%	Color (moist)	%	Type ¹	Loc ²	Texture	Rema	arks
0-16	10yr 4/2						Loamy/Clayey		
					·				
					. <u> </u>				
					. <u> </u>				
					·				
¹ Type: C=Co	oncentration, D=Depl	etion RI	M=Reduced Matrix	MS=Mas	sked San	Grains	² Location: P	L=Pore Lining, M=M	latrix
Hydric Soil				no mac				or Problematic Hyd	
Histosol			Polyvalue Belo	w Surfa	ace (S8) (I	LRR R.		ck (A10) (LRR K, L ,	
	vipedon (A2)		MLRA 149B		(/(,		airie Redox (A16) (L	
Black His			Thin Dark Surf	, ace (S9) (LRR R	, MLRA 1		cky Peat or Peat (S	
Hydroge	n Sulfide (A4)		High Chroma S	Sands (S	S11) (LRF	R K, L)	Polyvalu	e Below Surface (S8	B) (LRR K, L)
Stratified	Layers (A5)		Loamy Mucky	Mineral	(F1) (LR	R K, L)	Thin Dar	k Surface (S9) (LRF	R K, L)
Depleted	l Below Dark Surface	e (A11)	Loamy Gleyed	Matrix ((F2)		Iron-Mar	nganese Masses (F1	2) (LRR K, L, R)
