SITE PHOTOGRAPHS

Champlain Hudson Power Express

СНАМР	LAIN HUDS	SON POV	/FR F	XPRESS	KIE	WIT PROJECT NO.		
						CHAMPLAIN HUDSON POWER EXPRESS SEGMENT 9 (PACKAGE 5B) - CSX: SELKIRK RAIL YARD BYPASS LEGEND AND ABBREVIATIONS							
0	06/09/2023	ISSUED FOR CONSTRUCTION SUBMISSION	BV	TK									
No.	DATE	SUBMITTAL / REVISION DESCRIPTION	DB	APP	DRAWN BY: AR	DESIGNED BY: BV	APPROVED BY:	TK SCALE REV. NO.	AS SHOWN 0	DATE SH.NO.	06/09/2023 6 OF

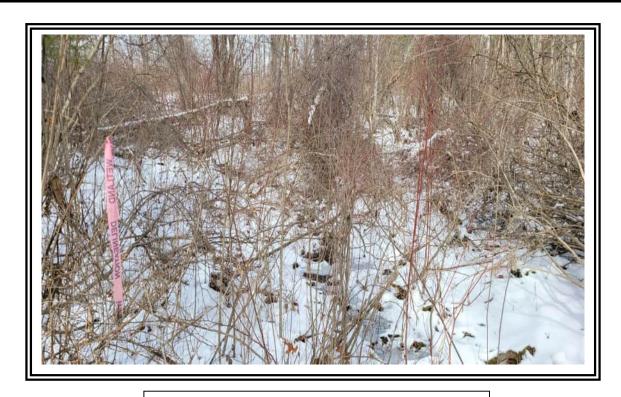
Wetland HA - View facing northeast.

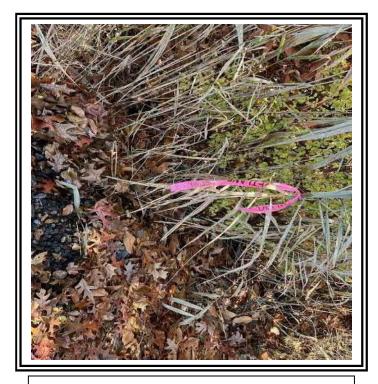
Profile Desc	ription: (Describe	to the de	th needed to docur	nent the i	ndicator	or confirm	the absence	of indicators.)
Depth	Matrix		Redo	x Feature:	<u>s</u>			
(inches)	Color (moist)	%	Color (moist)	%	Type ¹	Loc ²	Texture	Remarks
0-16	10YR/3/2	90	7.5yr/4/6	10			SiLo	Prominent redox
					_	_

Wetland HA- Soils

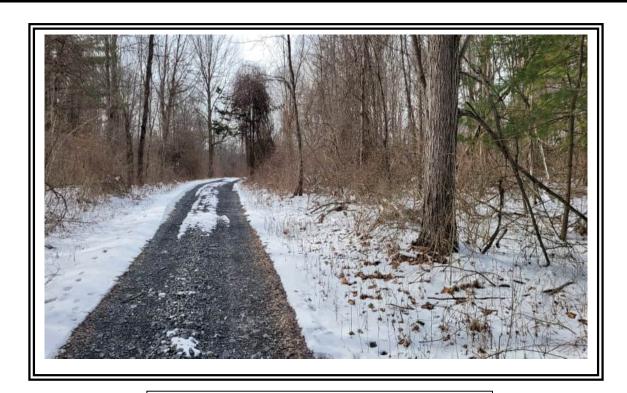
Upland GA & HA - View facing east.

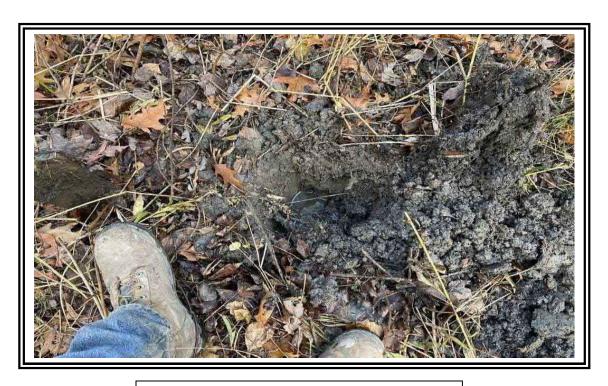
Upland GA/HA – Soils

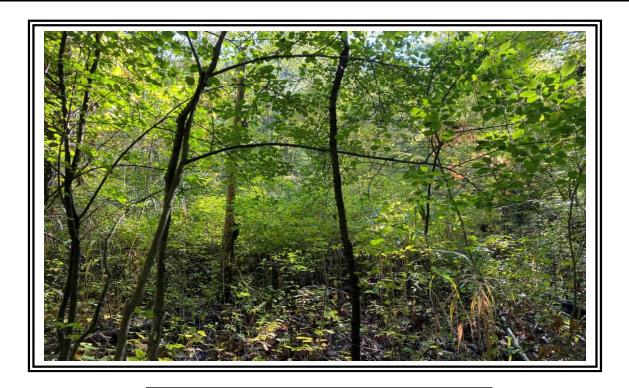
Remarks: (Explain alternative procedures he Red Maple Hardwood Swamp	ere or in a separate report.)			
HYDROLOGY				
Wetland Hydrology Indicators:			Secondary Indicators (n	ninimum of two required)
Primary Indicators (minimum of one is requir			Surface Soil Cracks	
Surface Water (A1)	X Water-Stained Leaves (B	9)	Drainage Patterns (· ·
High Water Table (A2)	Aquatic Fauna (B13)		Moss Trim Lines (B	•
Saturation (A3)	Marl Deposits (B15)	-	Dry-Season Water	
Water Marks (B1)	Hydrogen Sulfide Odor (C	•	Crayfish Burrows (C	•
Sediment Deposits (B2)	Oxidized Rhizospheres or			n Aerial Imagery (C9)
Drift Deposits (B3)	Presence of Reduced Iron		Stunted or Stressed	` '
Algal Mat or Crust (B4)	Recent Iron Reduction in	Tilled Solis (Co)	X Geomorphic Position	
Iron Deposits (B5)	Thin Muck Surface (C7)	·a\	Shallow Aquitard (D Microtopographic R	·
Inundation Visible on Aerial Imagery (B7 Sparsely Vegetated Concave Surface (B	· — · · · ·	is)	FAC-Neutral Test (I	` '

Wetland P5-Z-10- View facing east

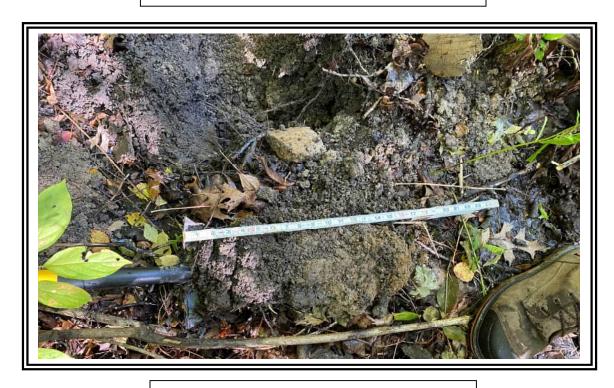
Profile Desc Depth	ription: (Describe t Matrix	o the de	-	ument th x Featur		ator or co	onfirm the absence of	f indicators.)	
(inches)	Color (moist)	%	Color (moist)	%	Type ¹	Loc ²	Texture	Remarks	
0-7	10YR 2/1	100			- 7		Loamy/Clayey		
7-16	10YR 4/1	80	10YR 5/6	20				Prominent redox conce	ntrations
7-10	10114 4/1		10113/0		<u>C</u>	M	Loamy/Clayey	Prominent redox conce	ntrations
¹Type: C=Co	oncentration, D=Deple	etion RI	M=Reduced Matrix M	 //S=Mas	ked San		² I ocation: P	L=Pore Lining, M=Matrix.	
Hydric Soil I		ouon, ru	vi rtoddocd ividirix, iv	no mas	itou ourit	a Graino.		or Problematic Hydric Soi	ils ³ :
Histosol (Dark Surface (S7)				ick (A10) (LRR K, L, MLRA	
	ipedon (A2)		Polyvalue Belo		ce (S8) (LRR R,		rairie Redox (A16) (LRR K ,	•
Black His			MLRA 149B		. , ,			cky Peat or Peat (S3) (LRI	*
Hydroger	n Sulfide (A4)		Thin Dark Surf	ace (S9)	(LRR R	, MLRA 1	I 49B) Polyvalu	e Below Surface (S8) (LRF	R K, L)

Wetland P5-Z-10- Soils

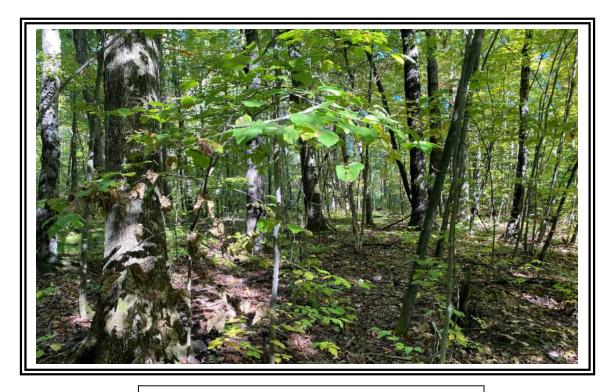
Upland P5-Z-10- View facing northwest

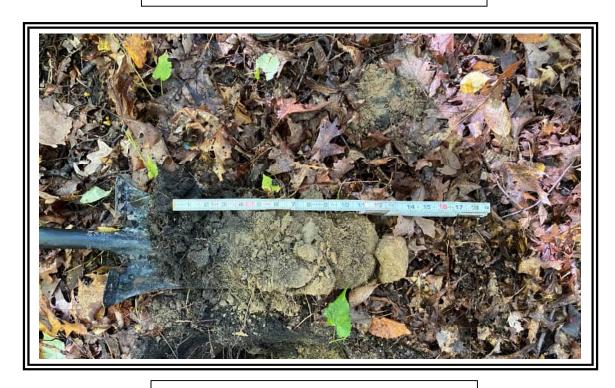
Upland P5-Z-10- Soils

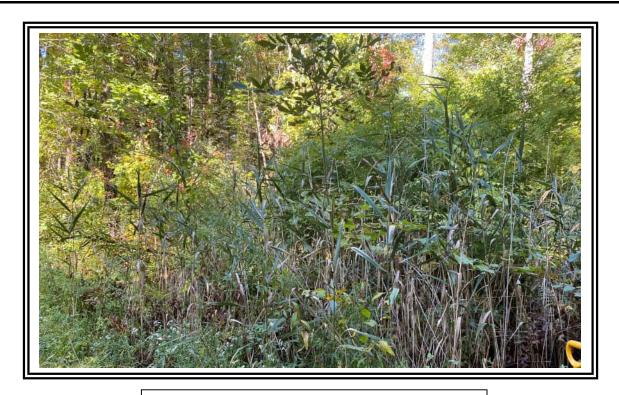
Wetland Hydrology Present?	Yes X No	If yes, optional We	tland Site ID:	
Remarks: (Explain alternative procedures he Common reed marsh.	ere or in a separate report.)			
HYDROLOGY				
Wetland Hydrology Indicators:			Secondary Indicators (m	ninimum of two required)
Primary Indicators (minimum of one is requir	ed: check all that apply)		Surface Soil Cracks	
Surface Water (A1)	Water-Stained Leaves (B	9)	Drainage Patterns (I	
High Water Table (A2)	Aquatic Fauna (B13)	5 /	Moss Trim Lines (B	•
Saturation (A3)	Marl Deposits (B15)		Dry-Season Water	·
Water Marks (B1)	Hydrogen Sulfide Odor (C) 1)	Crayfish Burrows (C	(8)
Sediment Deposits (B2)	X Oxidized Rhizospheres or	n Living Roots (C3)	Saturation Visible or	n Aerial Imagery (C9)
Drift Deposits (B3)	Presence of Reduced Iron		Stunted or Stressed	Plants (D1)
Algal Mat or Crust (B4)	Recent Iron Reduction in	Tilled Soils (C6)	X Geomorphic Positio	
Iron Deposits (B5)	Thin Muck Surface (C7)		Shallow Aquitard (D	·

Wetland BB-3- View facing north

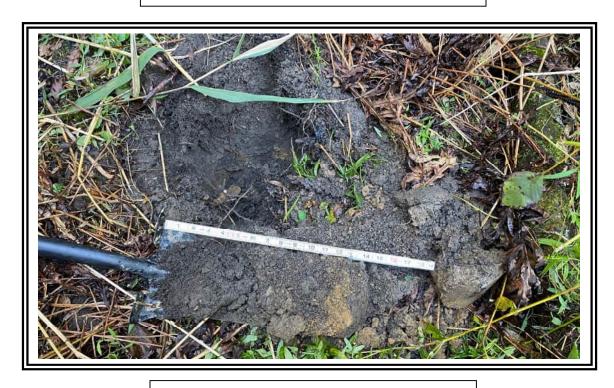
Wetland BB-3- Soils

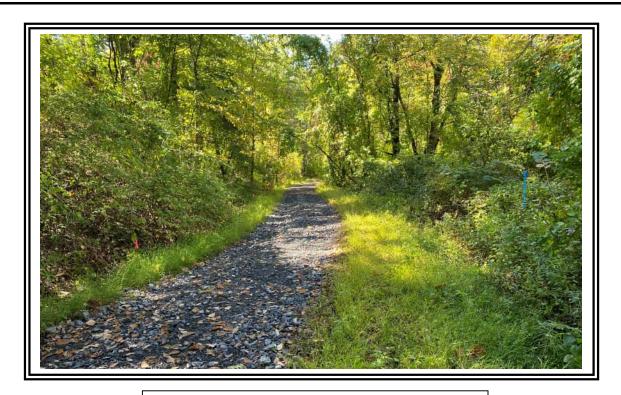
Upland CC-6- View facing west

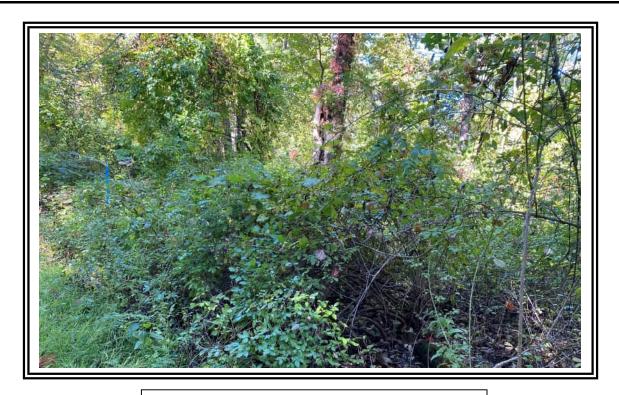
Remarks: (Explain alternative procedures he	ere or in a separate report.)			
Shrub swamp.				
HYDROLOGY				
Wetland Hydrology Indicators:			Secondary Indicators ((minimum of two required)
Primary Indicators (minimum of one is require	ed; check all that apply)		Surface Soil Crack	ks (B6)
Surface Water (A1)	Water-Stained Leaves (B	9)	Drainage Patterns	
— High Water Table (A2)	Aquatic Fauna (B13)		Moss Trim Lines (·
Saturation (A3)	Marl Deposits (B15)		Dry-Season Water	
Water Marks (B1)	Hydrogen Sulfide Odor (C	•	Crayfish Burrows (
Sediment Deposits (B2)	X Oxidized Rhizospheres or			on Aerial Imagery (C9)
Drift Deposits (B3)	Presence of Reduced Iron		Stunted or Stresse	·
Algal Mat or Crust (B4) Iron Deposits (B5)	Recent Iron Reduction in Thin Muck Surface (C7)	Tilled Solis (Co)	Geomorphic Positi Shallow Aquitard (
Inundation Visible on Aerial Imagery (B7		re)	Microtopographic I	
Sparsely Vegetated Concave Surface (B	· 	.3)	X FAC-Neutral Test	, ,

Wetland CC-6- View facing west

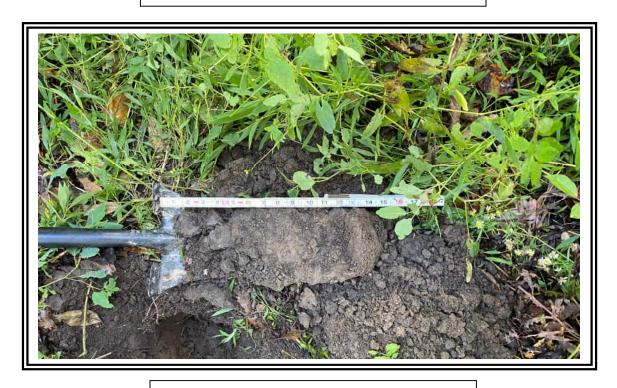
•	o the de	-			ator or co	onfirm the absence of	f indicators.)
Depth (inches)	Matrix Color (moist)	0/:		x Featur		Loc ²	Toyturo	Domarka
(inches)	Color (moist)		Color (moist)		Type ¹	Loc	Texture	Remarks
0-6	10YR 2/1	100					Loamy/Clayey	
6-16	10YR 3/1	80	10YR 3/6		<u>C</u>	PL/M	Loamy/Clayey	Prominent redox concentrations
								_

Wetland CC-6- Soils

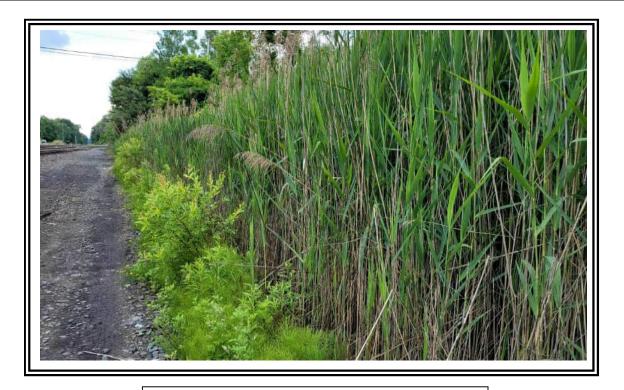
Remarks: (Explain alternative procedures here or Wetland IA, drainage on side of railway	in a coparato roporti,		
HYDROLOGY			
Wetland Hydrology Indicators:			ators (minimum of two required)
Primary Indicators (minimum of one is required; ch			Cracks (B6)
Surface Water (A1) High Water Table (A2)	Water-Stained Leaves (B9) Aquatic Fauna (B13)	<u> </u>	
Saturation (A3)	Marl Deposits (B15)	-	Water Table (C2)
Water Marks (B1)	Hydrogen Sulfide Odor (C1)	Crayfish Bur	
Sediment Deposits (B2)	Oxidized Rhizospheres on Living F	Roots (C3) 🔲 Saturation V	ʻisib l e on Aerial Imagery (C9)
☐ Drift Deposits (B3)	Presence of Reduced Iron (C4)	-	Stressed Plants (D1)
☐ Algal Mat or Crust (B4)☐ Iron Deposits (B5)☐ ☐	Recent Iron Reduction in Tilled So	-	Position (D2)
Inundation Visible on Aerial Imagery (B7)	Thin Muck Surface (C7) Other (Explain in Remarks)	Shallow Aqu	aphic Relief (D4)
Sparsely Vegetated Concave Surface (B8)	= other (Explain in Remaine)	FAC-Neutral

Wetland IA- View facing south

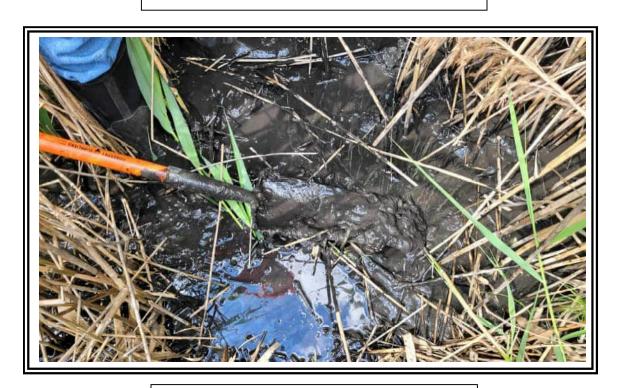
Wetland IA- Soils

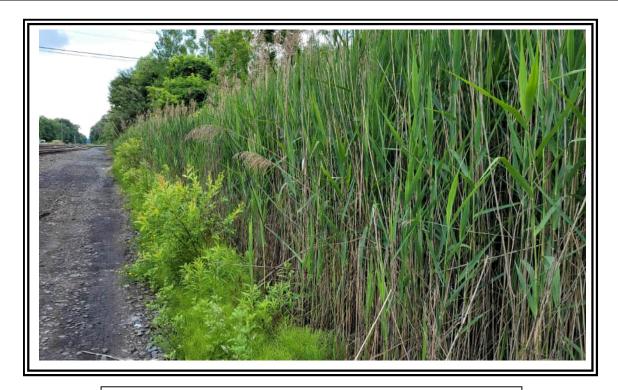
Upland IA (left side of photo)- view facing south

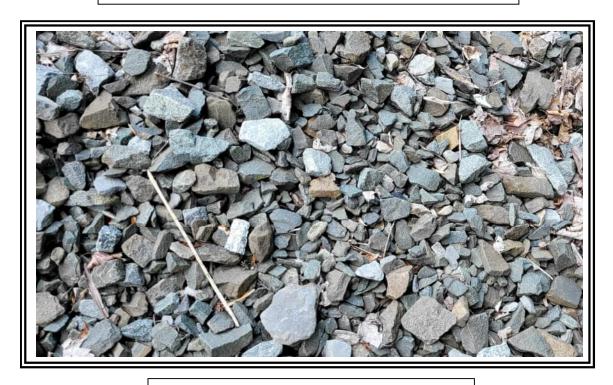
Upland IA - Soils

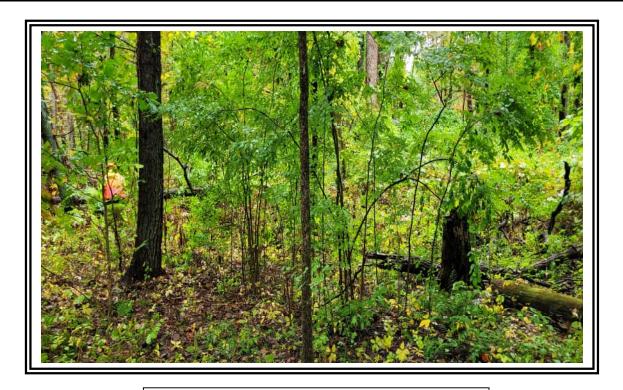
Wetland Hydrology Present?	Yes X No	If yes, optional We	etland Site ID: Wetland	P5-Y near flag P5-Y-13
Remarks: (Explain alternative procedures he	ere or in a separate report.)	<u> </u>		
Red maple hardwood swamp.				
HYDROLOGY				
Wetland Hydrology Indicators:			Secondary Indicators (n	ninimum of two required)
Primary Indicators (minimum of one is require			Surface Soil Cracks	
Surface Water (A1)	Water-Stained Leaves (B	9)	Drainage Patterns (•
High Water Table (A2)	Aquatic Fauna (B13)		Moss Trim Lines (B	·
Saturation (A3)	Marl Deposits (B15)	-	Dry-Season Water	
Water Marks (B1)	Hydrogen Sulfide Odor (C	•	Crayfish Burrows (C	·
Sediment Deposits (B2)	Oxidized Rhizospheres or			n Aerial Imagery (C9)
Drift Deposits (B3) Algal Mat or Crust (B4)	Presence of Reduced Iron Recent Iron Reduction in		Stunted or Stressed x Geomorphic Position	· ·
Iron Deposits (B5)	Thin Muck Surface (C7)	Illieu Solis (So)	Shallow Aquitard (D

Wetland P5-Y-13- View of wetland

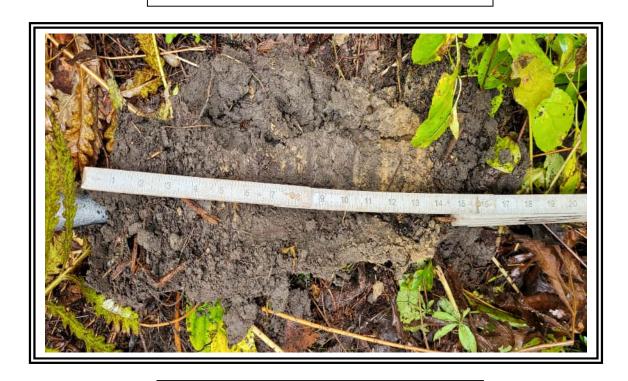
ription: (Describe t	o the de				ator or co	onfirm the absence of	f indicators.)
Depth	Matrix			Featur				
(inches)	Color (moist)		Color (moist)		Type ¹	Loc ²	Texture	Remarks
0-10	2.5Y 2.5/1	85	10YR 4/3	5	<u> </u>	<u>m</u>	Loamy/Clayey	Distinct redox concentrations
			10YR 5/6	10	<u> </u>	<u>m</u>		Prominent redox concentrations
10-15	2.5Y 4/1	60	10YR 2/1	10	<u> </u>	<u>m</u>	Sandy	Distinct redox concentrations
			10YR 4/3	10	<u> </u>	<u>m</u>		Distinct redox concentrations
			10YR 4/6	_20_	c	<u>m</u>		Prominent redox concentrations
15-18	10YR 2/1	95	10YR 5/3	5	c	<u>m</u>	Sandy	Distinct redox concentrations

Wetland P5-Y-13- Soils

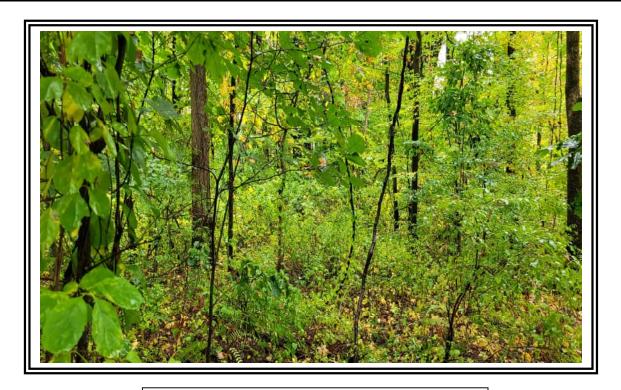
Wetland Hydrology Present?	Yes No _X	If yes, optional We	etland Site ID: Upland a	ndjacent to Wetland P5-Y			
Remarks: (Explain alternative procedures he	re or in a separate report.)						
Deciduous forest.							
LIVEROLOCY							
HYDROLOGY							
Wetland Hydrology Indicators:				ninimum of two required)			
Primary Indicators (minimum of one is require		•••	Surface Soil Cracks				
Surface Water (A1)	Water-Stained Leaves (B9	19)	Drainage Patterns (
High Water Table (A2) Saturation (A3)	Aquatic Fauna (B13) Marl Deposits (B15)	Moss Trim Lines (B16) Dry-Season Water Table (C2)					
Water Marks (B1)	Hydrogen Sulfide Odor (C	~1)	Crayfish Burrows (C				
Sediment Deposits (B2)	Oxidized Rhizospheres or	•		n Aerial Imagery (C9)			
Drift Deposits (B3)	Presence of Reduced Iron		Stunted or Stressed	=			
Algal Mat or Crust (B4)	Recent Iron Reduction in						
Iron Deposits (B5)	Thin Muck Surface (C7)	Shallow Aquitard (D3)

Upland P5-Y-13- View of upland

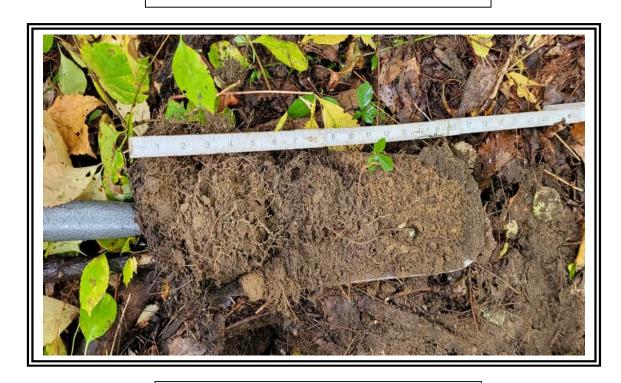
Depth	Matrix			x Featur			onfirm the absence o	· · · · · · · · · · · · · · · · · · ·	J.,		
(inches)	Color (moist)	<u>%</u>	Color (moist)	%_	Type ¹	Loc ²	Texture		Remar	ks	
0-9	10YR 3/2	100					Loamy/Clayey				
9-18	10YR 4/3		10YR 5/3	30	c	<u>m</u>	Loamy/Clayey	Faint	redox con	centrations	<u>. </u>

Upland P5-Y-13- Soils
