Appendix I. Waterbody Inventory and Wetland Delineation Report

**WETLAND AND STREAM DELINEATION REPORT
STONY POINT HORIZONTAL DIRECTIONAL DRILL**

**STONY POINT
ROCKLAND COUNTY
NEW YORK**

JUNE 2022

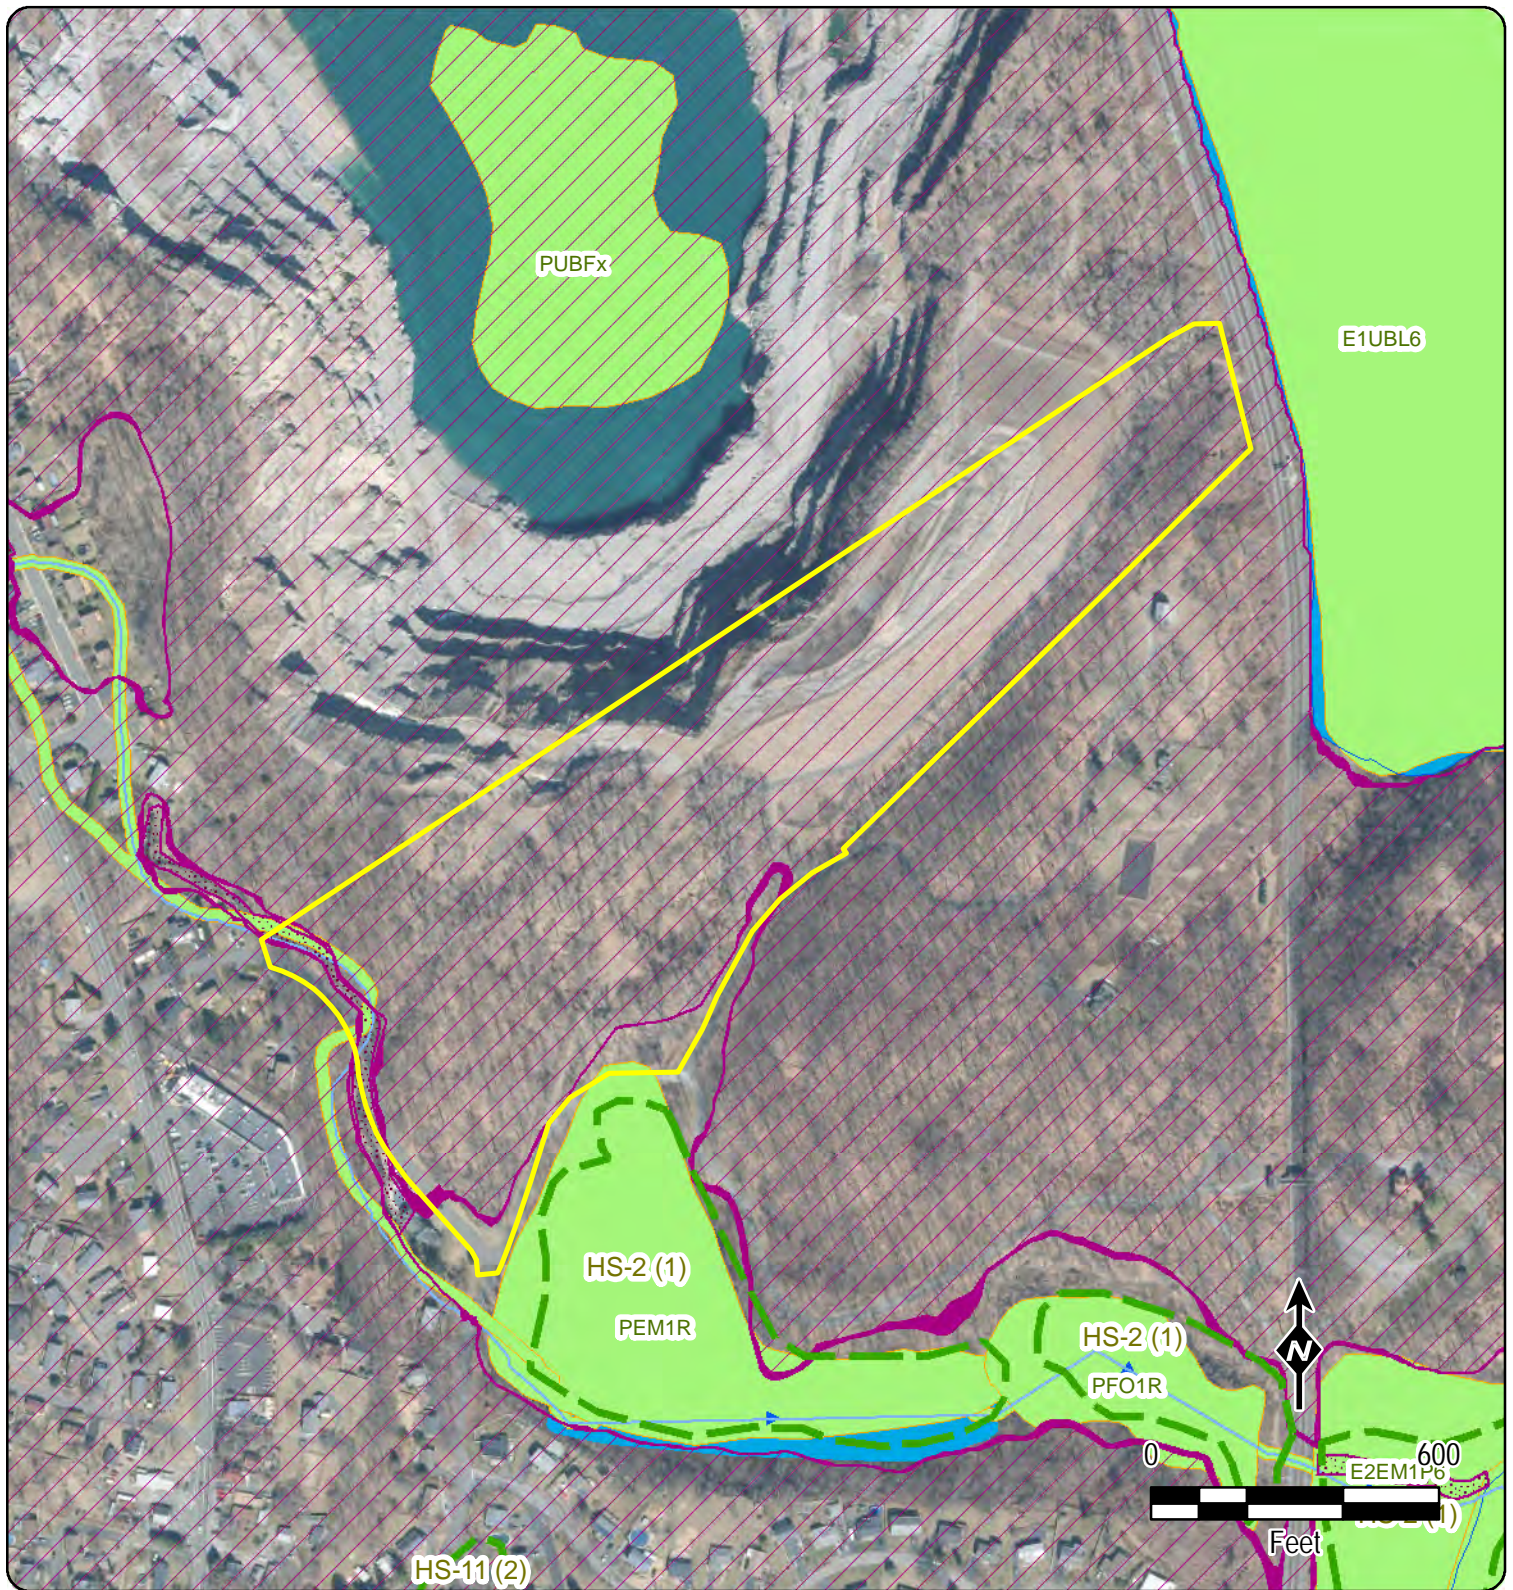
Figure 2
Federal and State
Resource and Floodplain Mapping

FEMA maintains materials developed to support flood hazard mapping for the National Flood Insurance Program (NFIP). According to FIRM panel 36087C0101G, effective 3/3/2014, the southwestern portion of the Project Area is within a 100-year, floodplain flood zone AE, which is a high-risk floodplain. The remaining portion of the Project Area is area of minimal flood zone hazard, flood zone X (see **Figure 2, Appendix A**).

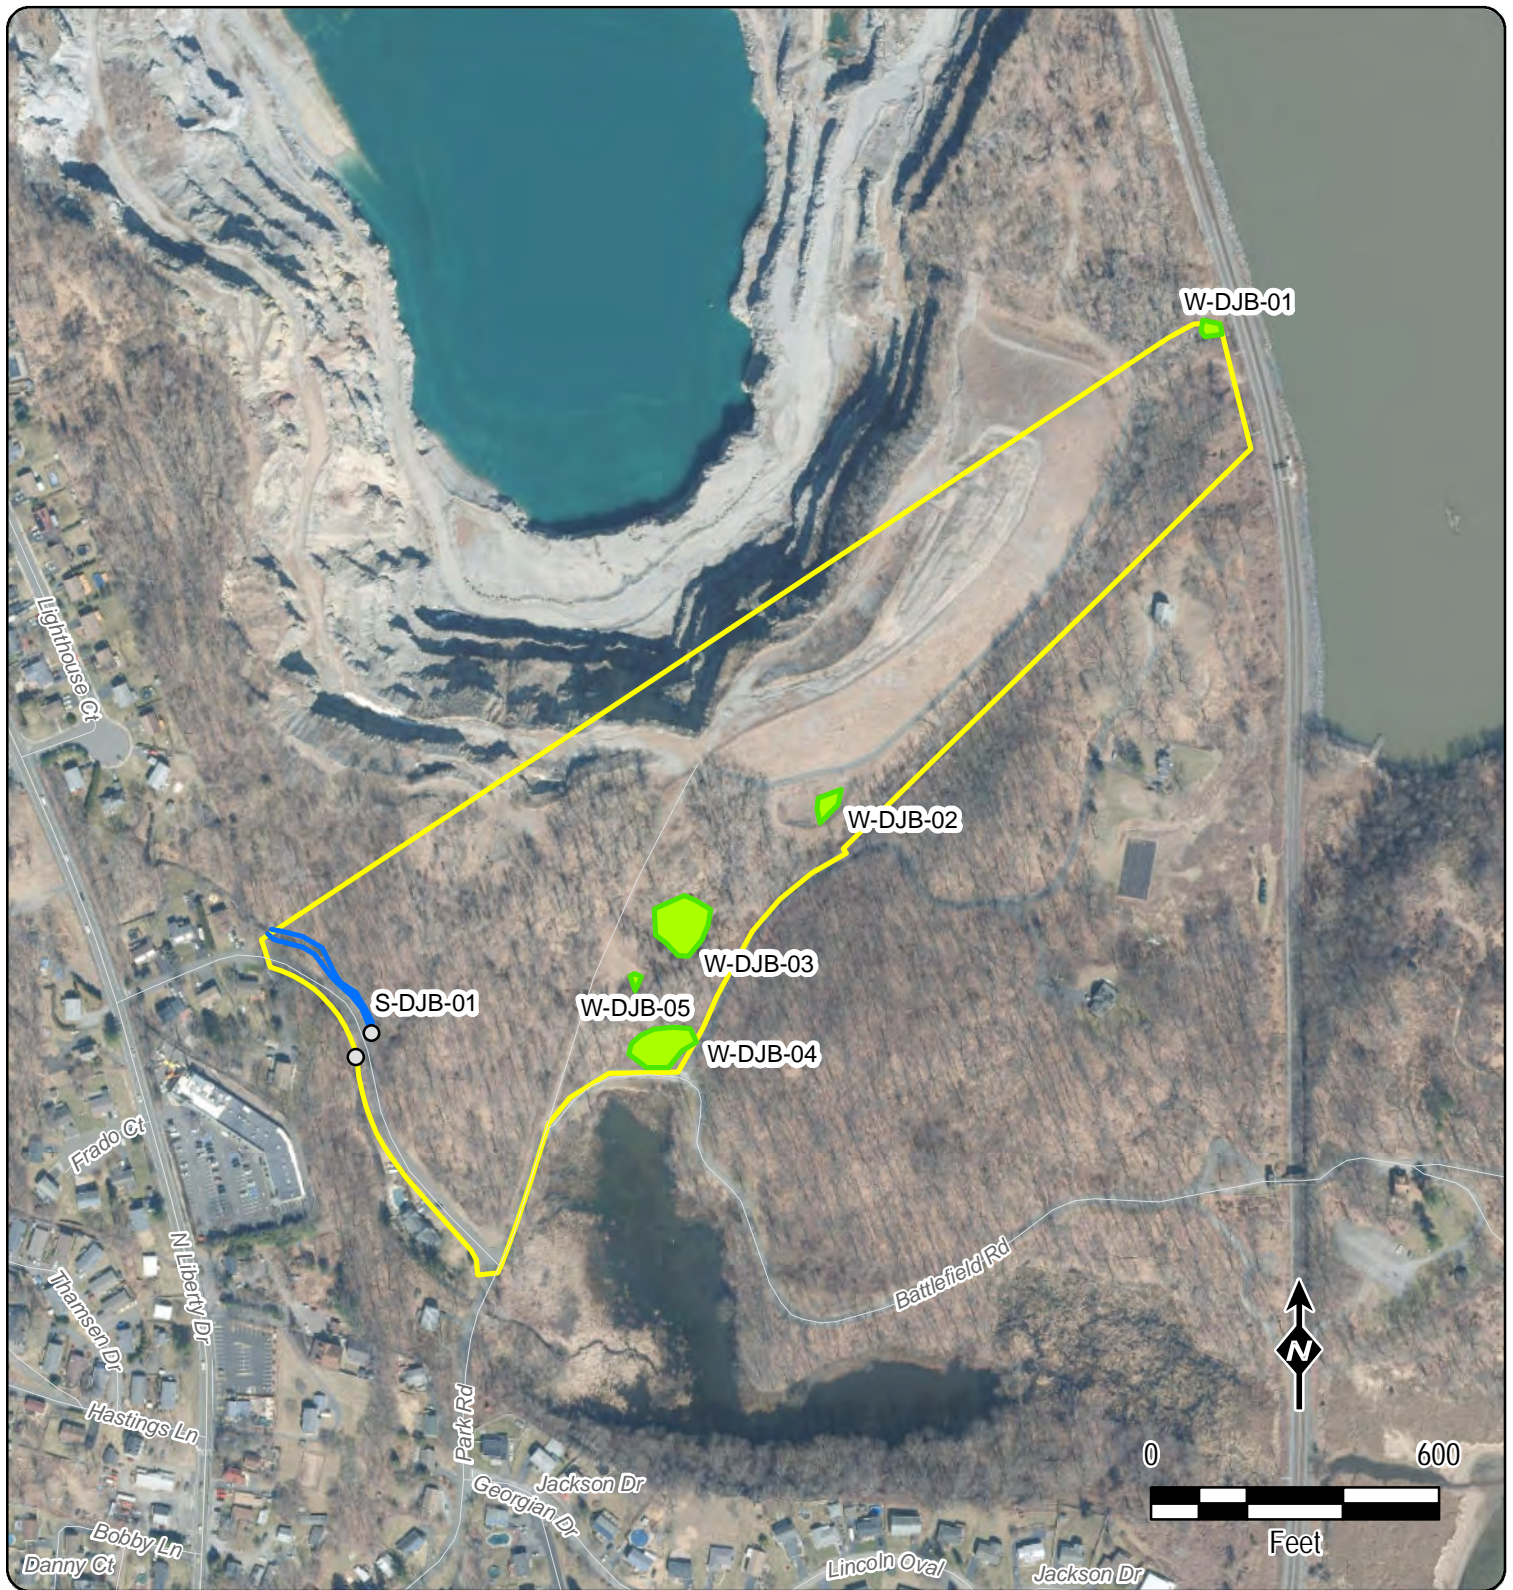
- Survey Area
- Culvert
- Delineated Stream TOB
- Delineated Wetland
- Road

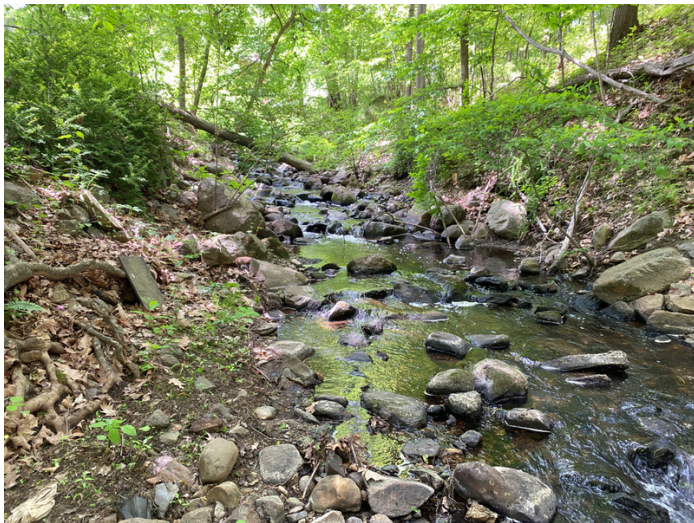
Upstream Photo:

The stream identified in the Project Area was perennial in nature, flowing along a shallow gradient approximately one to five percent. Stream substrates observed were boulders, gravel, cobble, silt and clay. The lower downstream reach of the streambed was a concrete base with a constructed wall along the right bank. The stream enters a concrete box culvert, flows under Park Road, and exits the Project Area. Stream depths ranged from zero to six inches deep. The stream contains aquatic habitat, such as overhanging vegetation and riffle-pool sequences, and sufficient flow to establish and support fish populations.

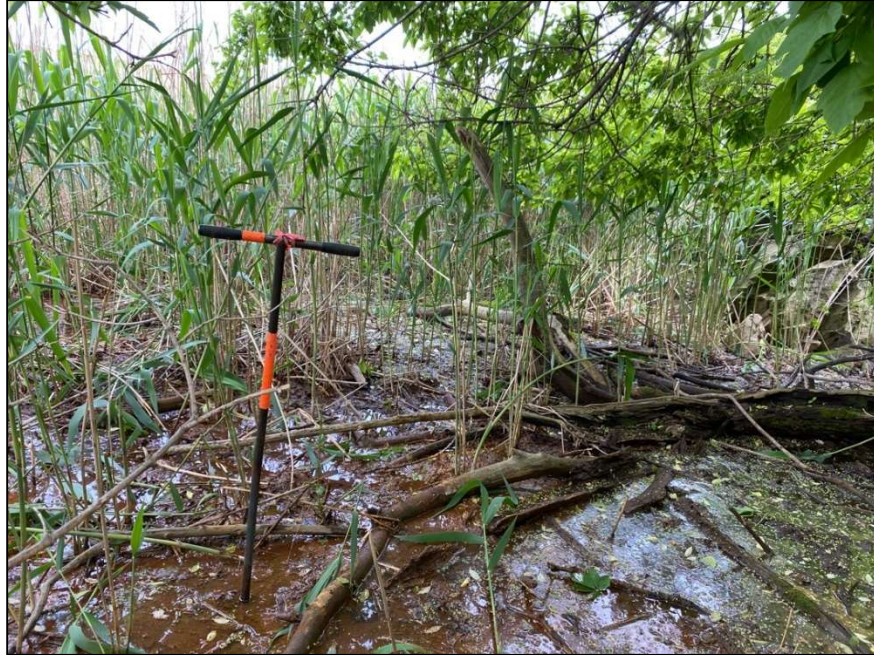
Photograph 1. View of PEM Wetland W-DJB-01 located along the eastern portion of the Project Area boundary. Wetland hydrology is evident in the foreground with common reed as the dominant vegetation. Photo taken on 5/27/2022.

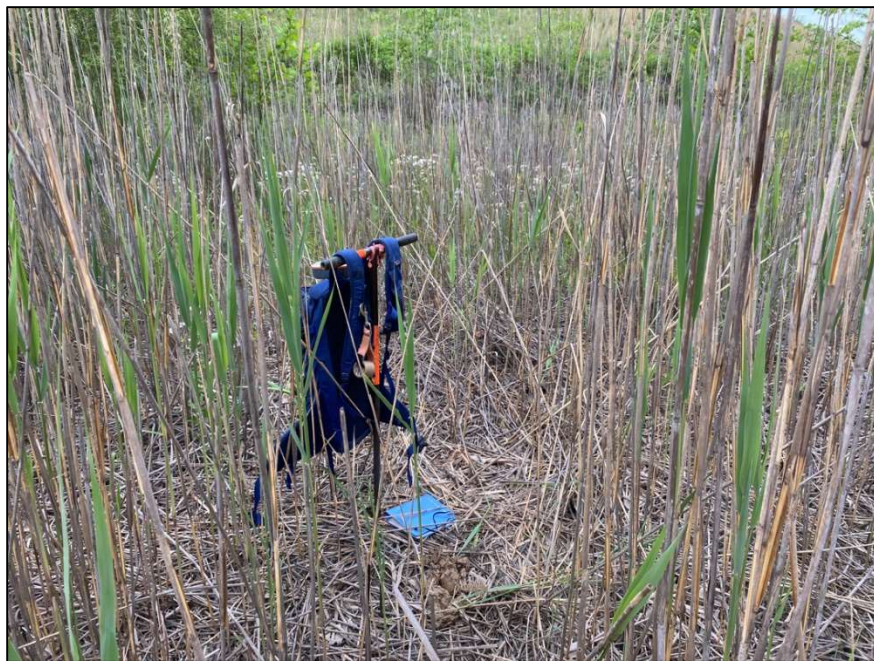
Photograph 2. View of PEM Wetland W-DJB-02 located near the center of the Project Area. Common reed was the dominant vegetation within this depressional feature formerly utilized as a stormwater basin. Photo taken on 5/27/2022.

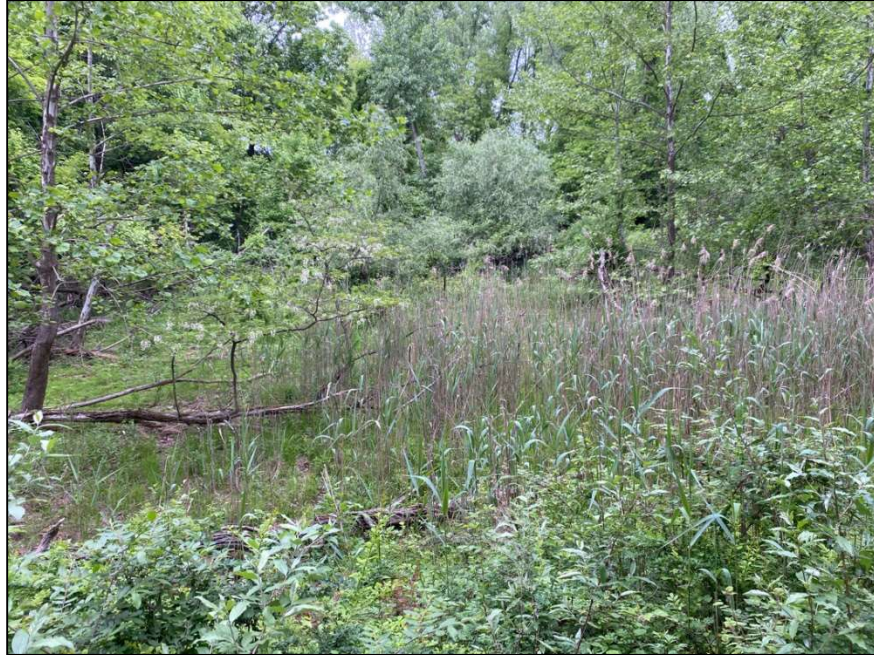
Photograph 3. View of PEM Wetland W-DJB-03 located in the southwestern portion Project Area. Common reed was the dominant vegetation as seen in the background. Photo taken on 5/27/2022.

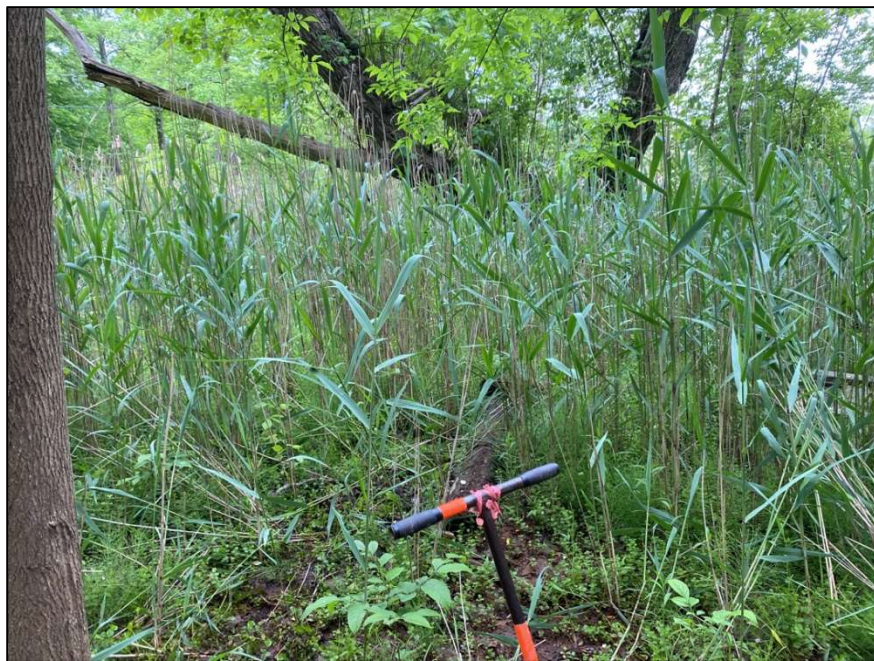
Photograph 4. View of PFO Wetland W-DJB-04 located along the southwestern portion Project Area. Common reed was the dominant emergent vegetation seen in the foreground with a forested canopy. Photo taken on 5/27/2022.

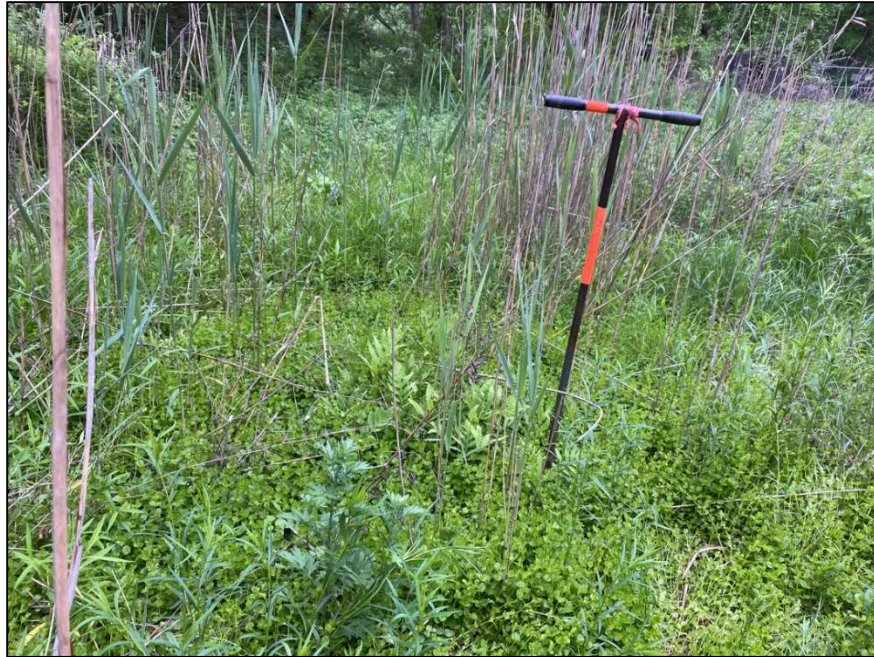
Photograph 5. View of PEM Wetland W-DJB-05 located in the southwestern portion Project Area. Common reed as the dominant vegetation seen in the background. Photo taken on 5/27/2022.

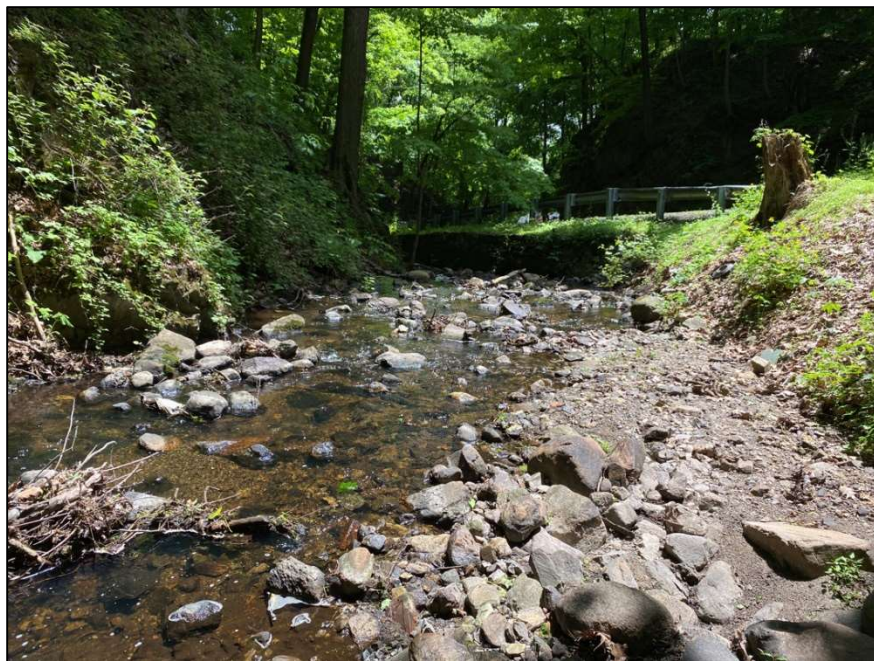
Photograph 6. View of perennial Stream S-DJB-01 located in the northwestern portion Project Area. Photo taken on 5/27/2022.

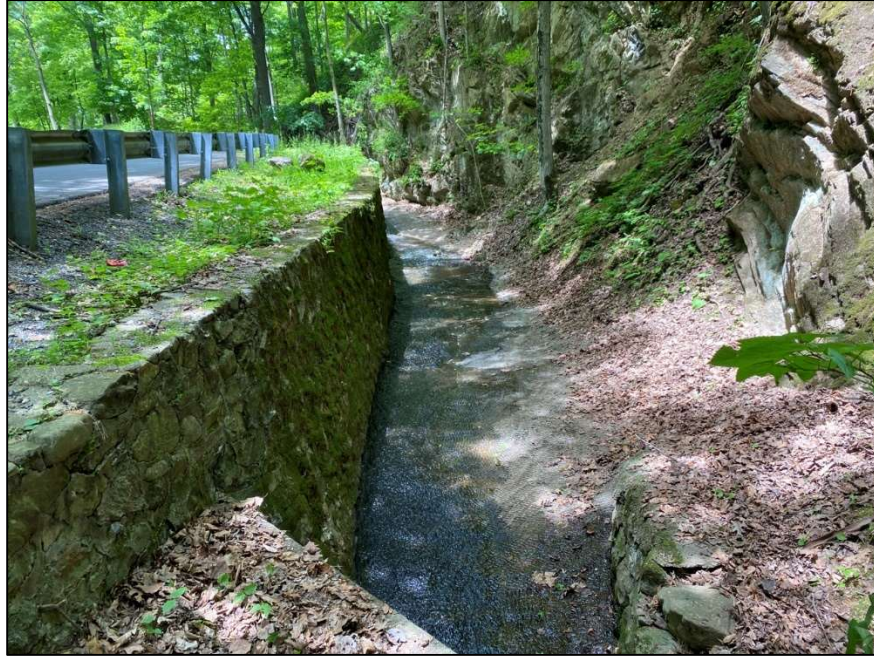
Photograph 7. Upstream view of perennial Stream S-DJB-01. Photo taken on 5/27/2022.

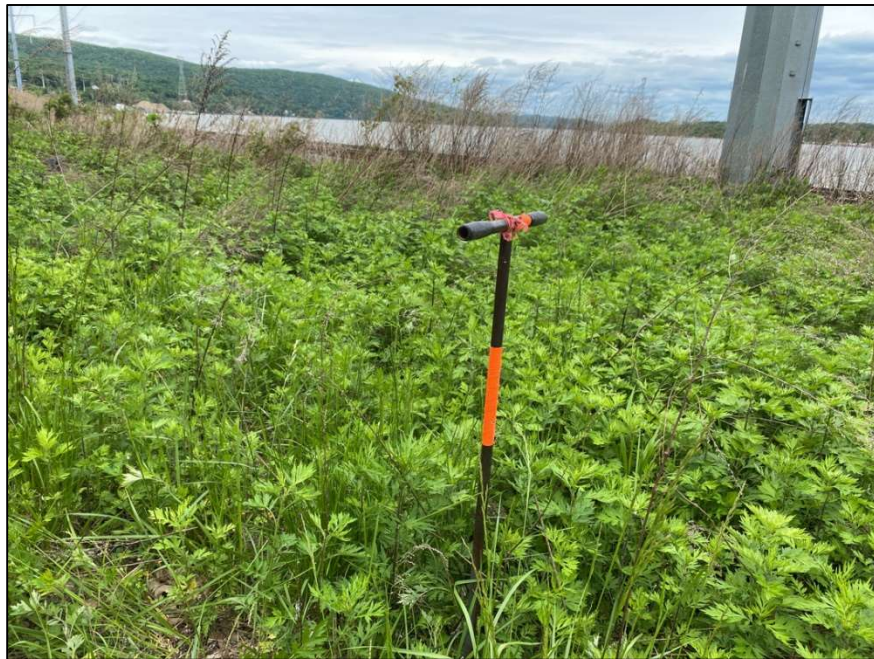
Photograph 8. Typical view of the upland habitat at USACE data point W-DJB-01_UPL-1 in the eastern portion of the Project Site. Photo taken on 5/27/2022.

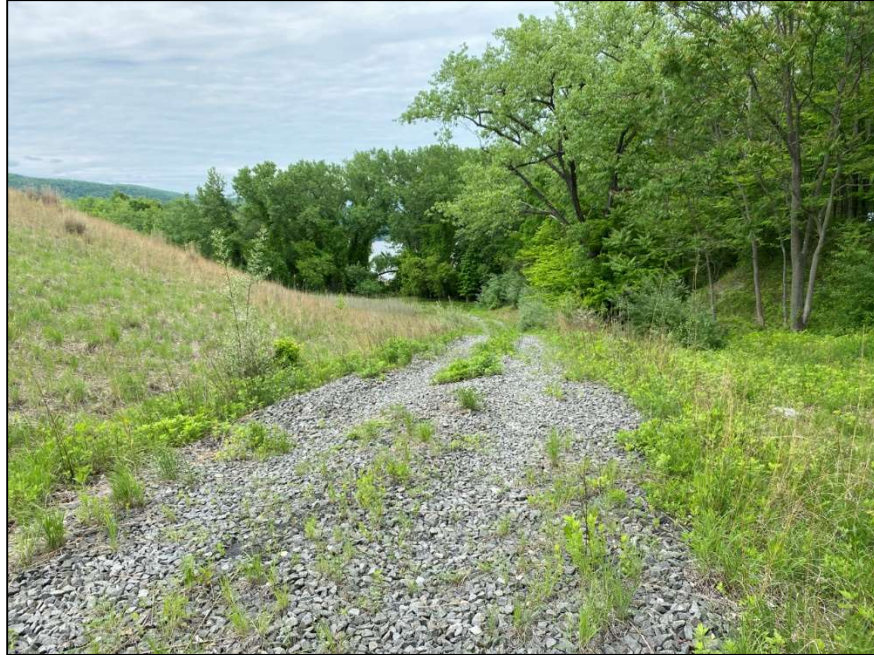
Photograph 9. View of upland habitat in the eastern portion of the Project Site. Photo taken on 5/27/2022.

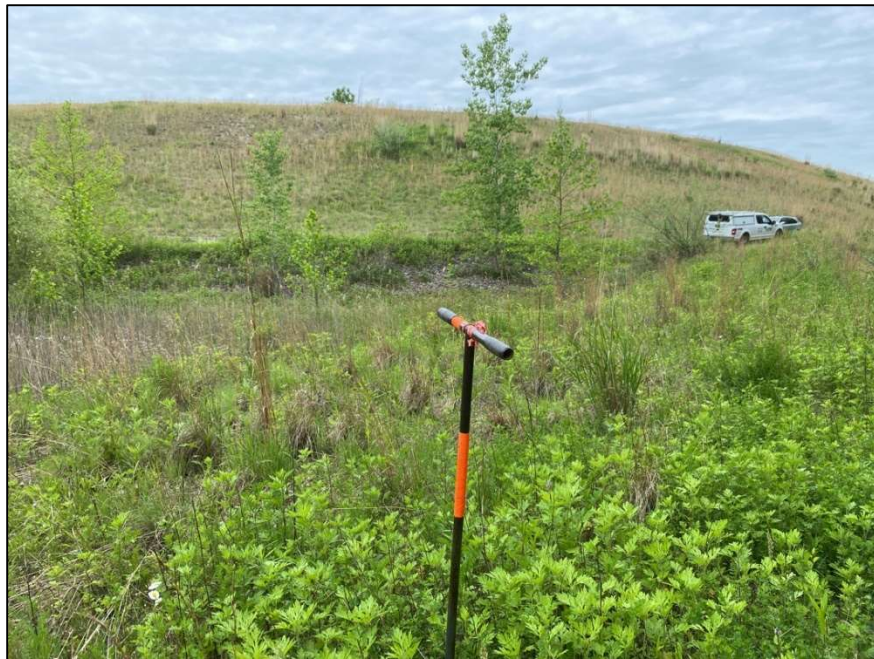
Photograph 10. View of upland habitat overlooking Wetland W-DJB-02. Photo taken on 5/27/2022.

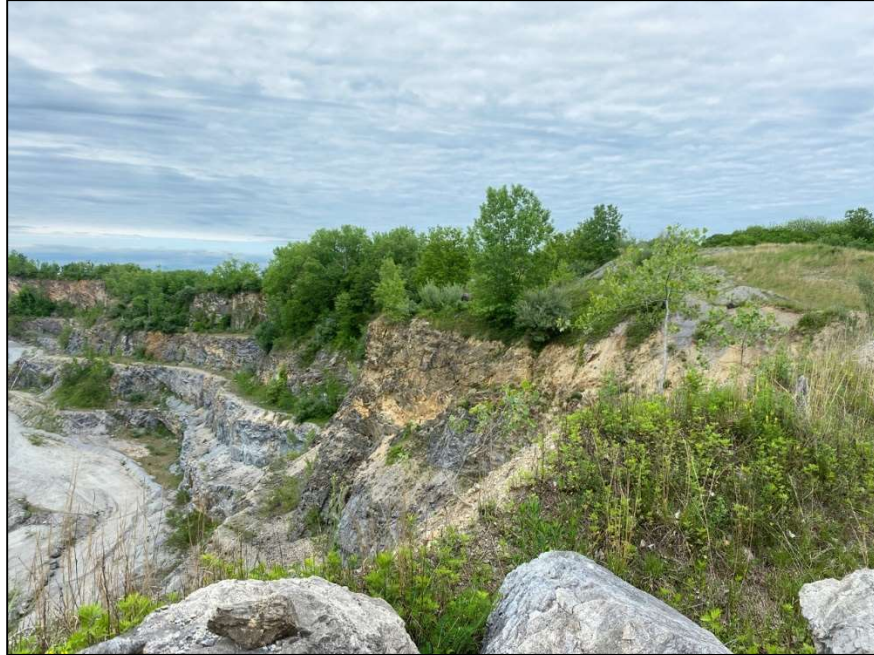
Photograph 11. View of quarry pits located along the northern Project Site boundary. Photo taken on 5/27/2022.

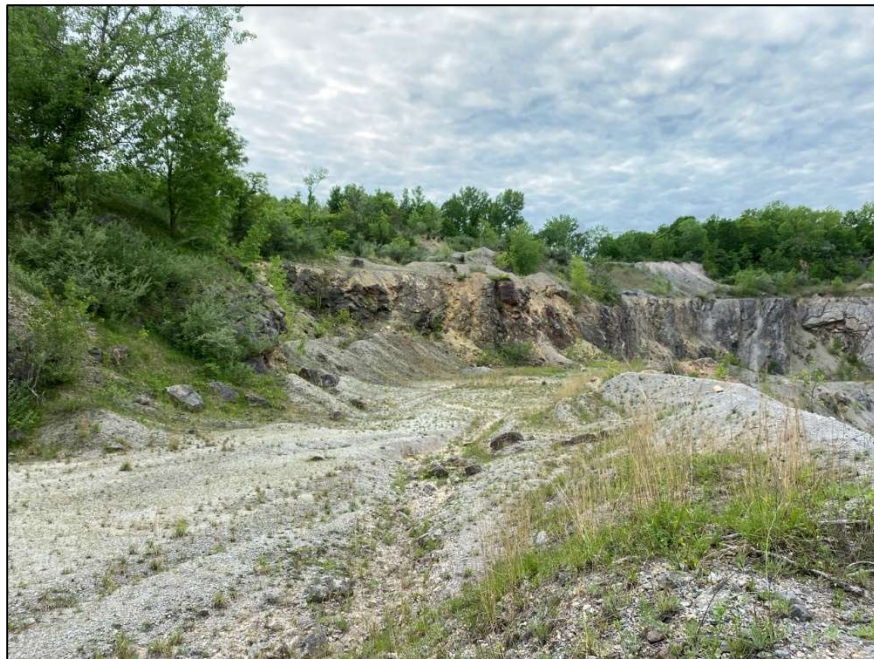
Photograph 12. View of quarry pits located along the northern Project Site boundary. Photo taken on 5/27/2022.
