CHAMPLAIN HUDSON POWER EXPRESS

CROSSING ARRANGEMENT - LAKE CHAMPLAIN

Unknown CI Owner
CHPE Crossing Reference LC-20, LC-20A & LC-20B

CHAMPLAIN HUDSON POWER EXPRESS CROSSING ARRANGEMENT – LC-20, LC-20A & LC-20B

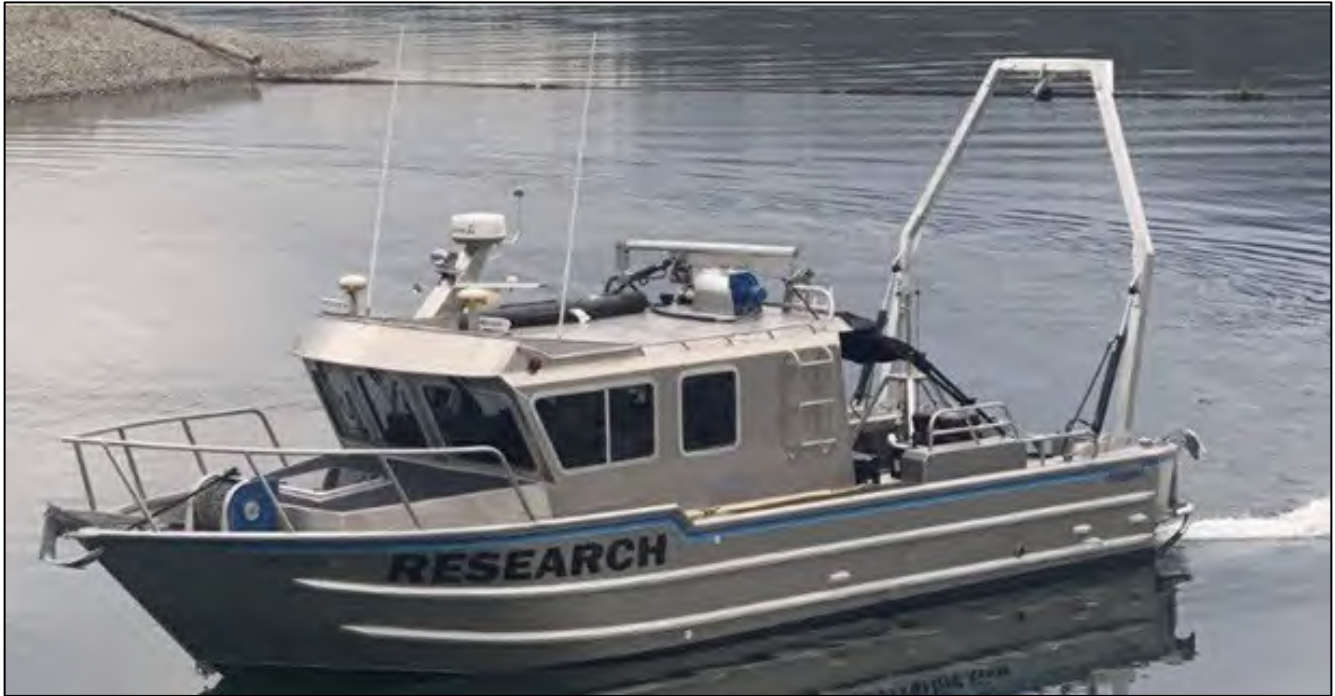
Figure 1. M/V *Yeti*

The M/V *Yeti* is a custom-built research and survey platform designed to operate in the ultra-shallow nearshore and intra-coastal environment (Figure 1). With a cruising speed of 25 knots and less than 3' draft, the vessel can access a variety of survey areas. The vessel was mobilized with the survey equipment mentioned above in the configuration shown in Figure 2.
