CHAMPLAIN HUDSON POWER EXPRESS

CROSSING ARRANGEMENT - LAKE CHAMPLAIN

Unknown CI Owner

CHPE Crossing Reference LC-20, LC-20A & LC-20B

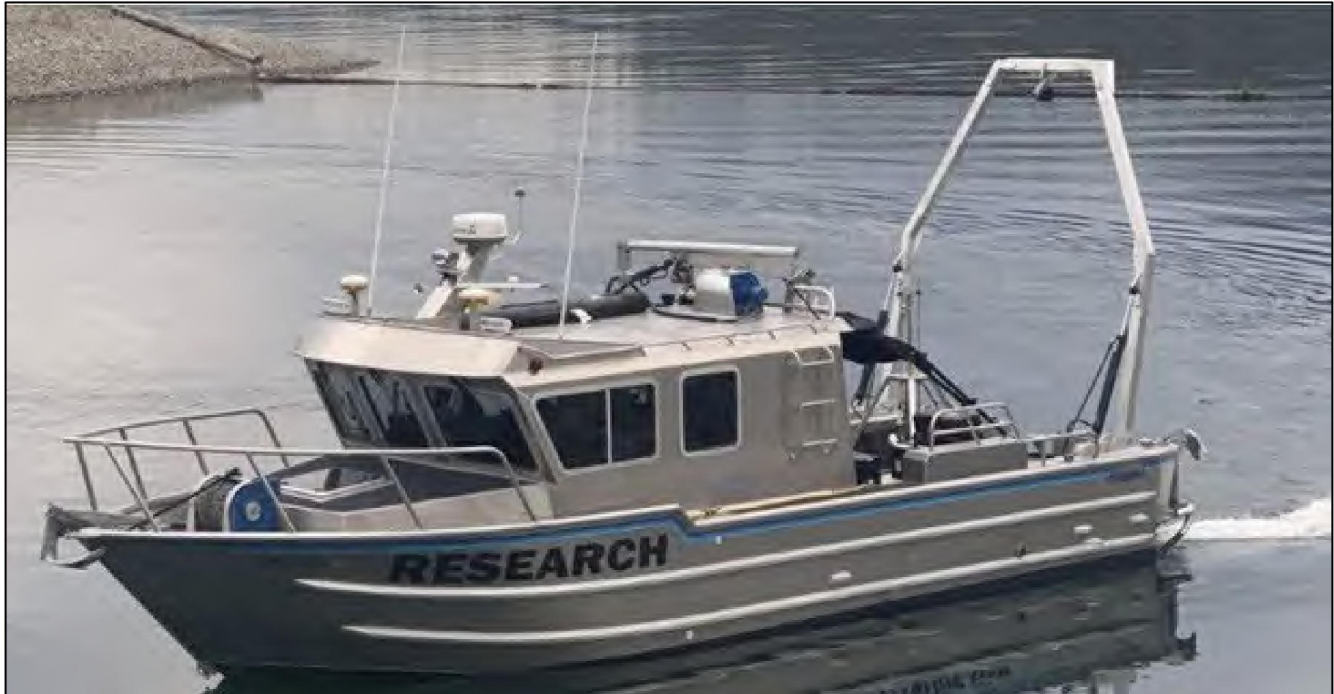
Figure 1. M/V *Yeti*

The M/V *Yeti* is a custom-built research and survey platform designed to operate in the ultra-shallow nearshore and intra-coastal environment (Figure 1). With a cruising speed of 25 knots and less than 3' draft, the vessel can access a variety of survey areas. The vessel was mobilized with the survey equipment mentioned above in the configuration shown in Figure 2.

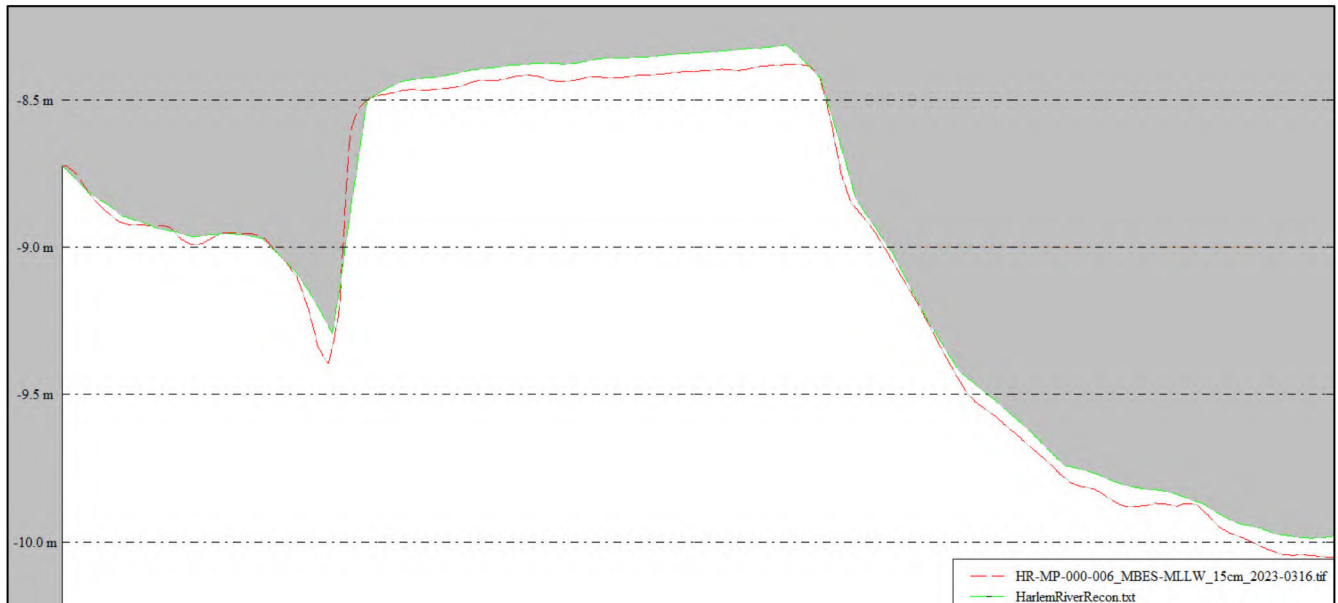
Figure 10. MBE Profile Comparison

Patch Test data were acquired over a known discrete feature provided by the client. Horizontal and vertical comparisons were made of the M/V *Yeti* data against the provided dataset with acceptable results.

Figure 10 shows the profile over the discrete feature, showing zero horizontal offset and an average vertical offset of less than 0.041m.

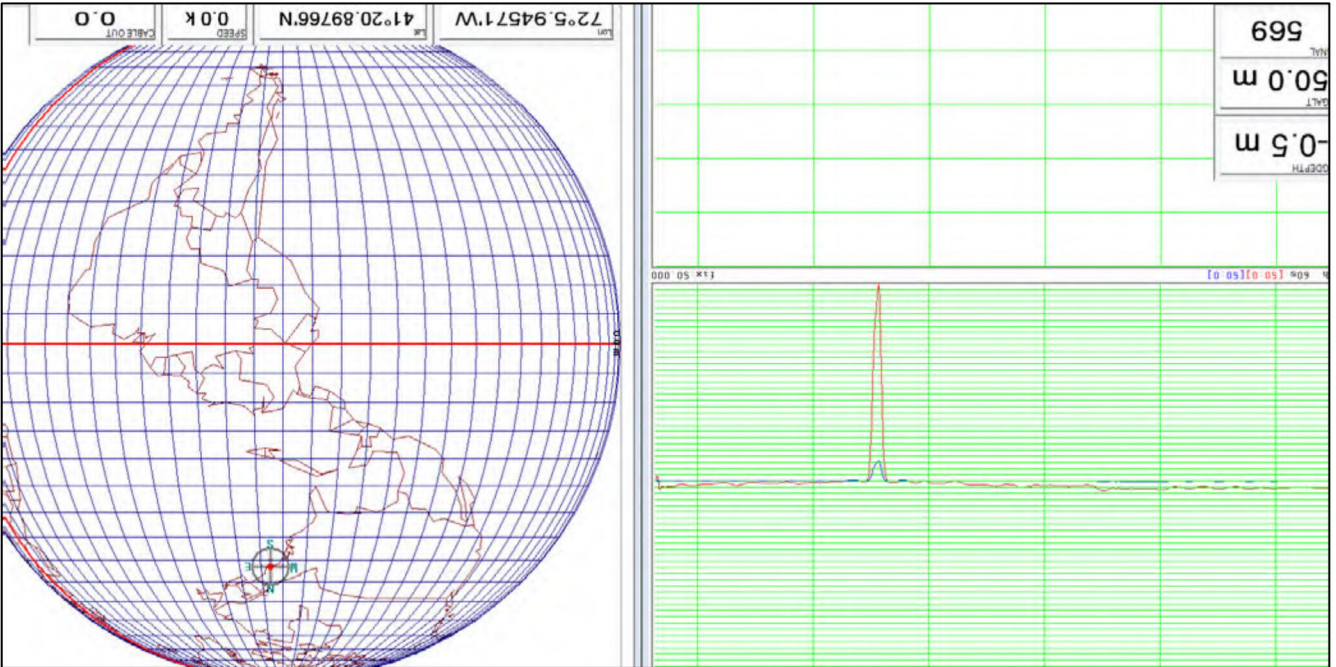
Figure 11. Geometrics G-882 Magnetometer Wrench Test

Two Geometrics' G-822 cesium vapor marine magnetometers in a Transverse Gradiometer (TVG) frame were utilized for the duration of the survey. A wrench test was performed to ensure the magnetometer was in proper working order on deck (Figure 11).

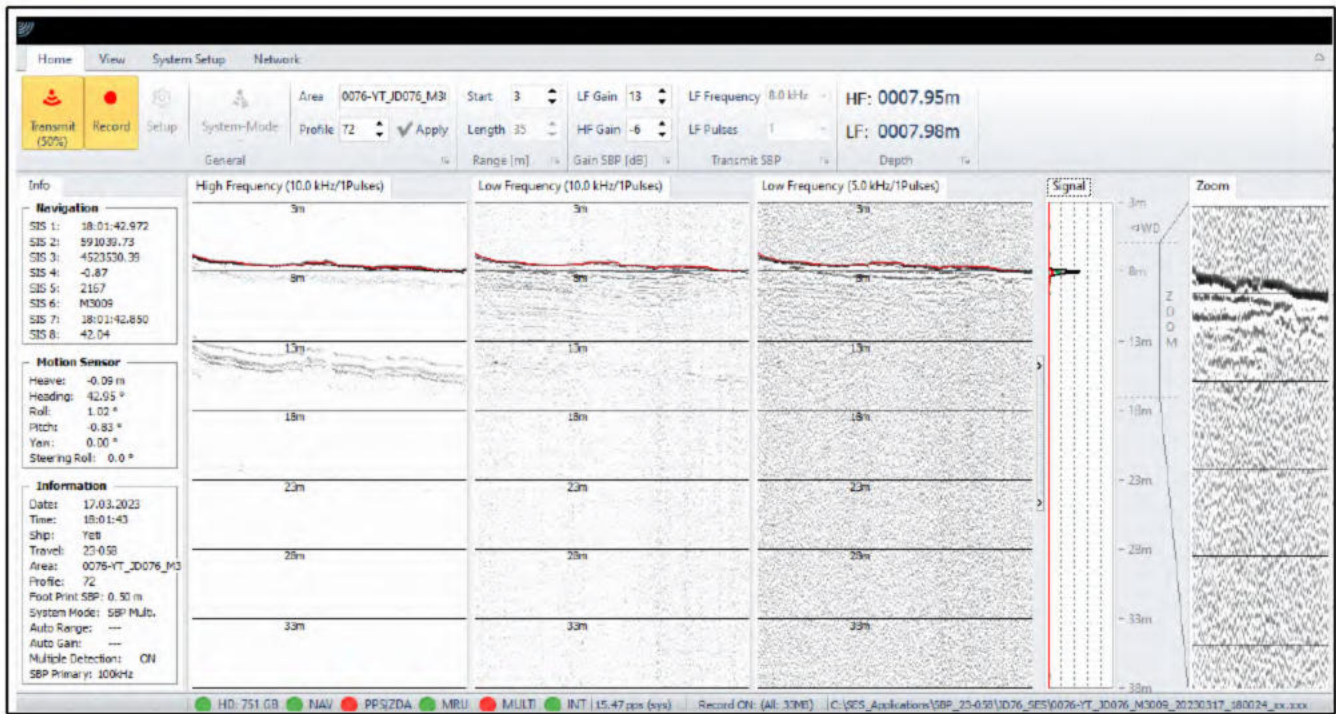
Figure 16. SBP Wet Test

Data were acquired at survey specifications to ensure that data, time, heave, and navigation were received and logged properly (Figure 16).

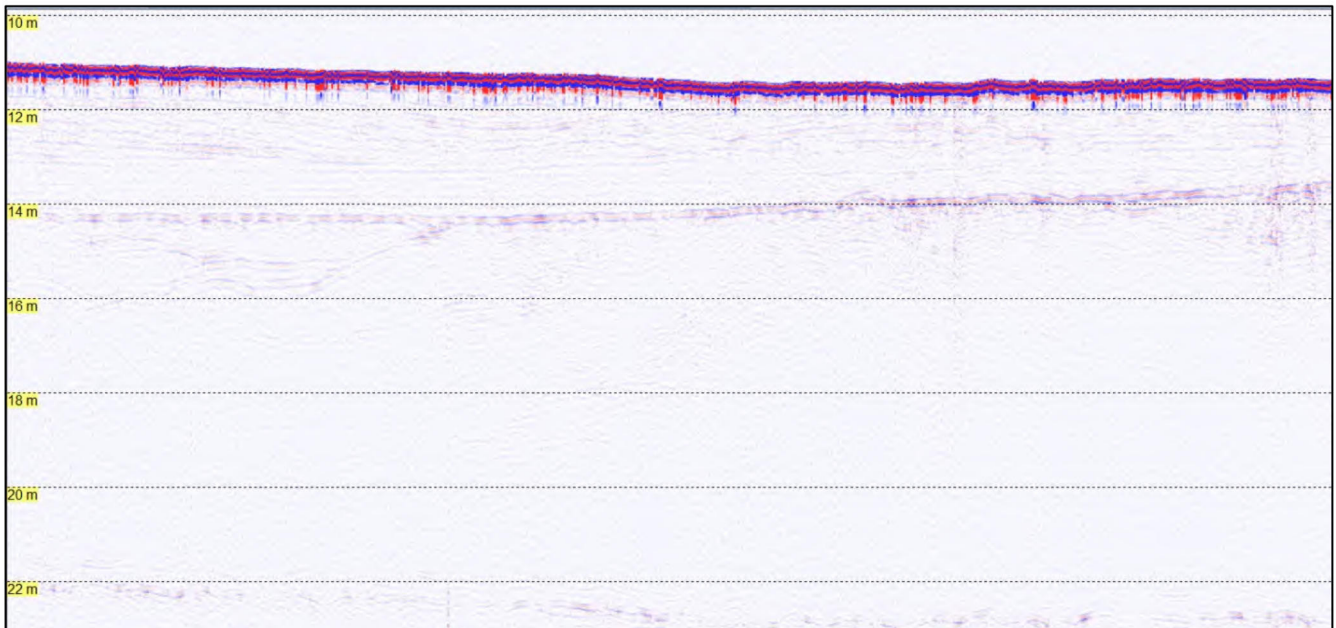
Figure 18. SBP Geological Assessment

SBP data were reviewed to assess interpretability to 10ft BSB (where acoustic penetration was achieved based on substrate conditions). Data quality demonstrated interpretability well below the 10ft requirement. (Figure 18).
