Appendix 6-E: Wetlands & Waterbodies Technical Memorandum

Date: May 8, 2024
To: Fredrik Hallsten – NKT
From: Frank Smolenski, Senior Environmental Scientist
Project: Champlain Hudson Power Express Project
Subject: Harlem River Bulkhead; Wetlands Assessment

Project Description and Purpose

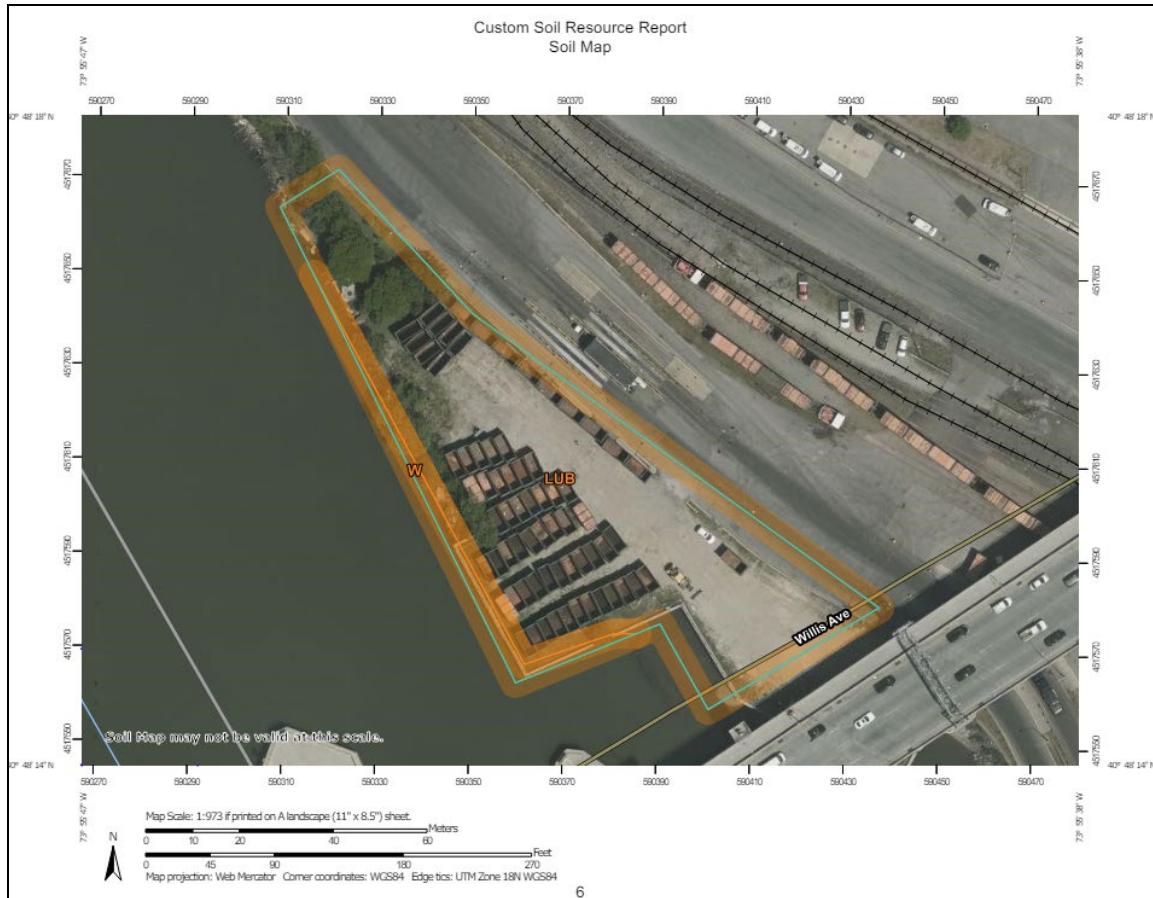
Figure 4 NRCS Soil Survey

A review of the US Department of Agriculture's Natural Resources Conservation Service (NRCS) Soil Survey³ indicated that the Project Area's soils consist entirely of those classified LUB, or Laguardia-Urban land complex, 3 to 8 percent slopes (see Figure 4). Such soils are described as "Loamy-skeletal human-transported material" on base or side slopes consisting of "cobbly-artifactual coarse sandy loam" to a depth of 79 inches. Their properties are listed as well-drained, medium runoff, not subject to flooding or ponding, and non-hydric (i.e., not wetlands). To the west of these soils, the listing was "W," for open "water," (i.e., Harlem River).

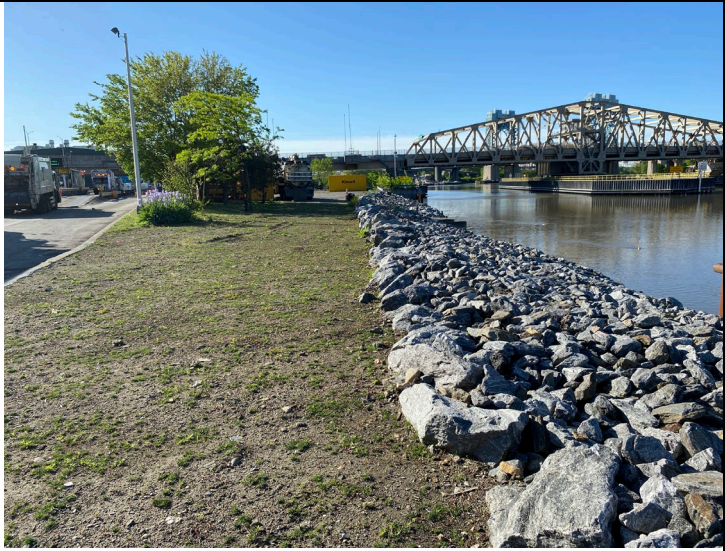
View southeast from the end of the Project site. Note the rock bulkhead and sparse vegetation.

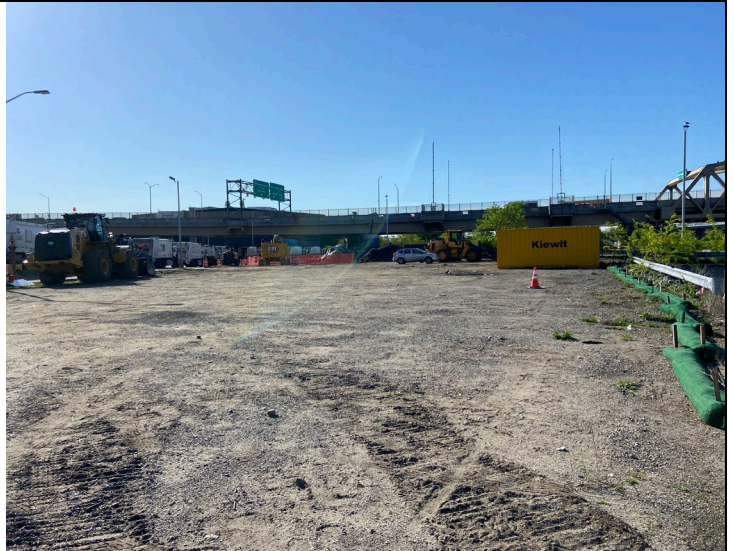
View southeast towards the lower limit of the site. Note the presence of heavily compacted yet well drained stony coarse sandy loam.

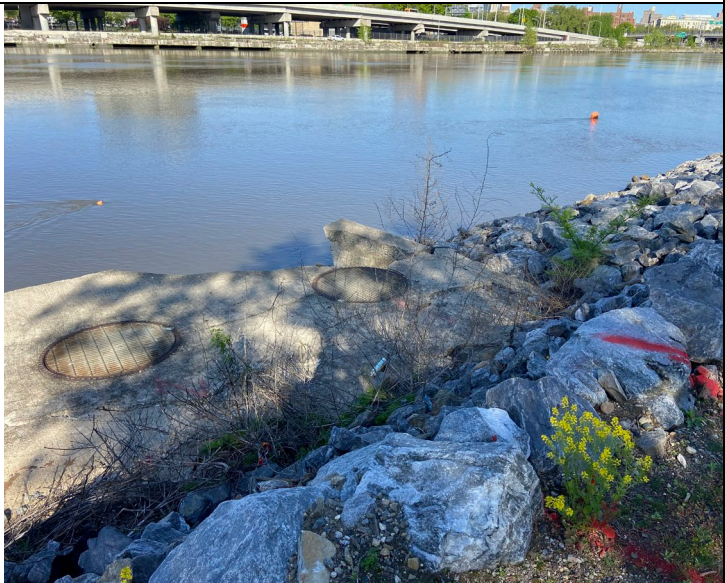
View west of the Harlem River. Note the existing manholes built into the bulkhead, with sparse adventive vegetation behind in soils.

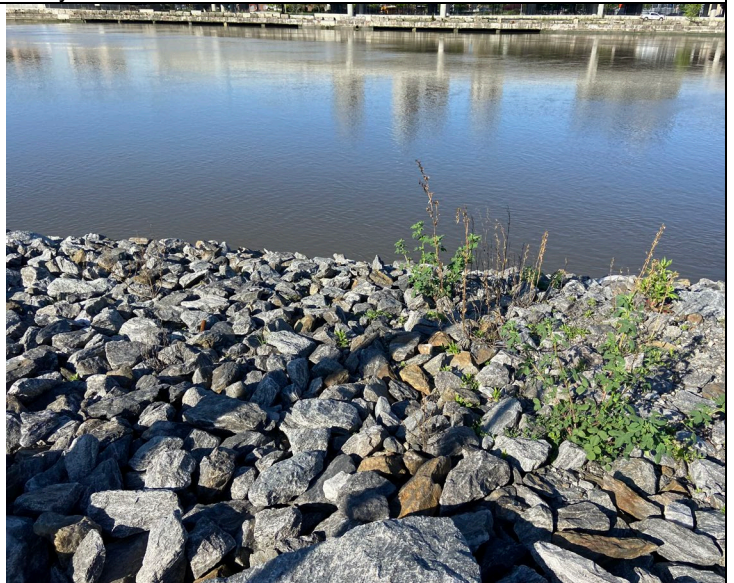
View west of the Harlem River. Note additional adventive vegetation growing in the bulkhead rocks.
