**SUPPLEMENTAL CULTURAL RESOURCES MANAGEMENT PLAN**  
**Champlain Hudson Power Express HVDC Transmission Line Project**  
**Fort Edward to Milton (Segments 4 & 5, Package 3)**

HAA 4268-83  
SHPO 09PR03910

REVISED July 2023

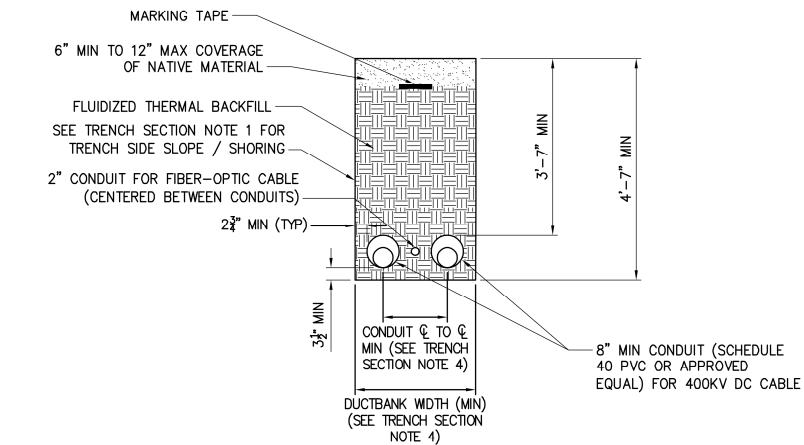
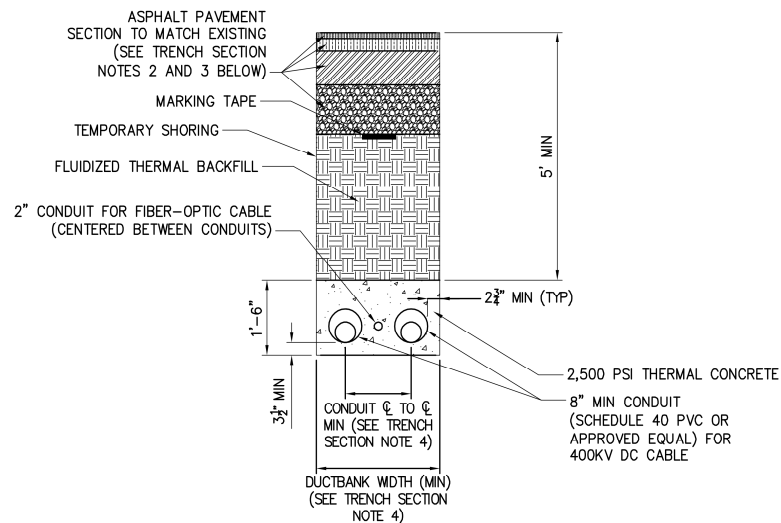
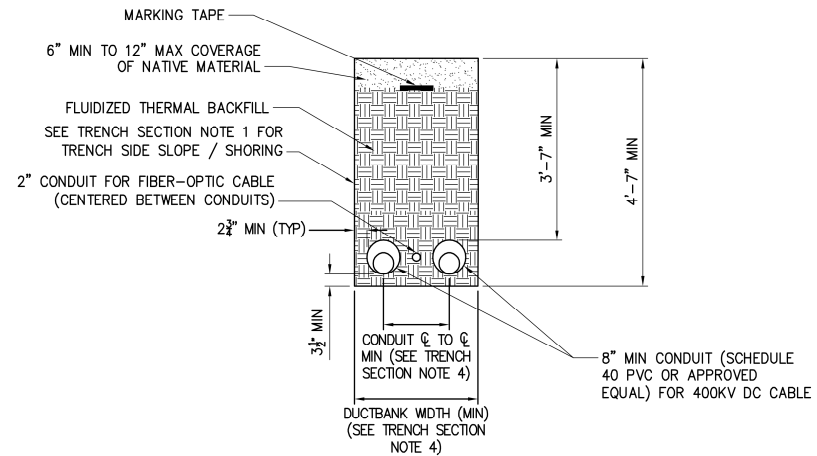
**1A TRENCH SECTION - TYPICAL**  
 NOT TO SCALE

Figure 1. Typical open trench (railroad) and duct bank (roadway) and agricultural land installation of the cable illustrated.

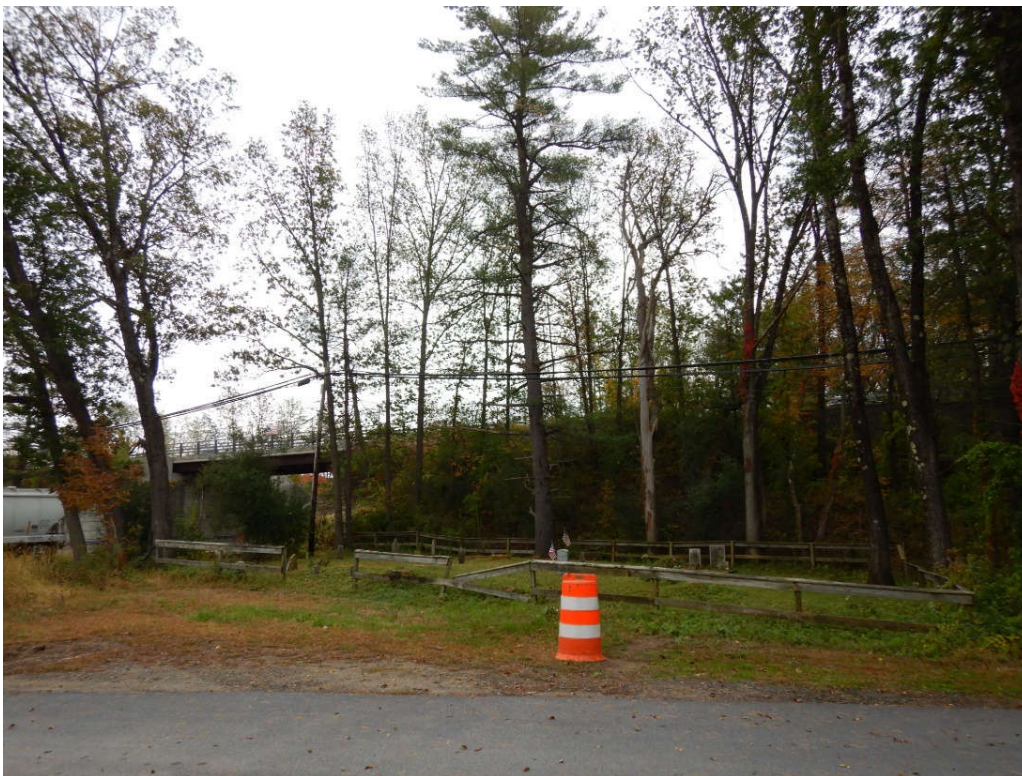
Photo 1. View southeast of the Cady Cemetery, the cable will be installed via HDD under the cemetery and nearby embankment.

The burial plot is north of Geyser Road and immediately west of the CP Rail corridor which is set below the natural grade of the hill (Photo 1). Geyser Road passes over the rail corridor via a short bridge. The road and railroad were once nearly at grade to the cemetery but now Geyser Road sits on an embankment. The cemetery is relatively small in scale containing seven marked plots (*The Daily Gazette* 7 September 2010). Formerly it may have contained at least 18 markers. The cemetery was in use between 1798 to about 1862. The burial plot includes a stone to Jeremiah Cady, a Revolutionary War soldier, however, he is thought to be buried elsewhere (*Times Union* 4 October 2010). A wooden post-rail fence currently surrounds the cemetery. As the parcel was always part of a larger family farm, no metes and bounds were ever described for the cemetery in related property deeds.

Additional protective measures will be implemented including temporary fencing, construction call-outs, and signage, similar measures will be undertaken for the stone abutment of the rail bridge near Splice 113 (see Section 6.4). Further, an archeologist will monitor the HDD installation.

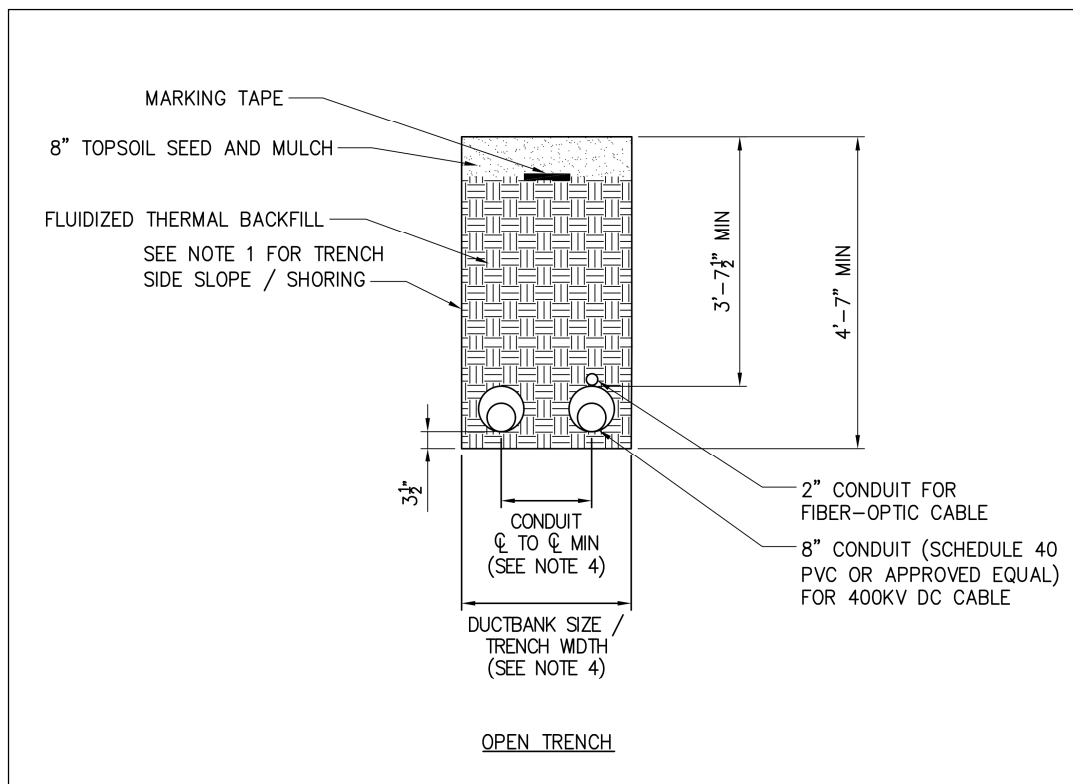
Figure 1. Typical open trench (railroad) installation of the cable illustrated.

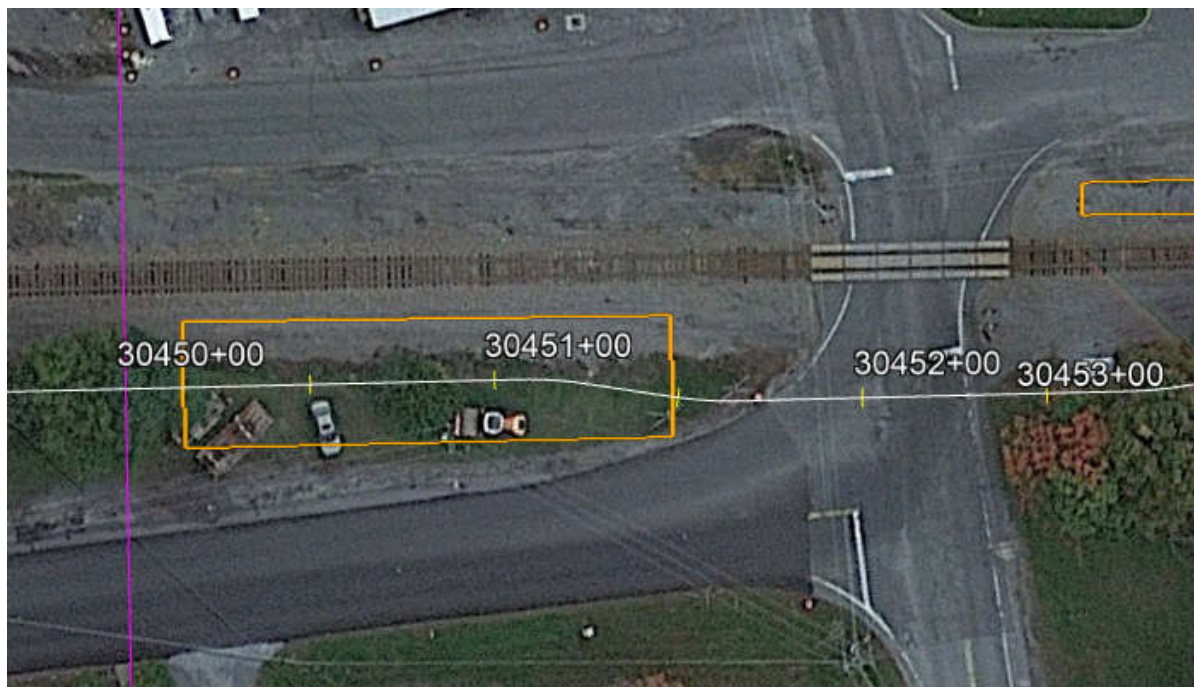
Figure 2. Aerial view of the CHPE Site 4 location outlined in orange. The cable route center point is in white with stations numbers shown. View north to the left of the image.

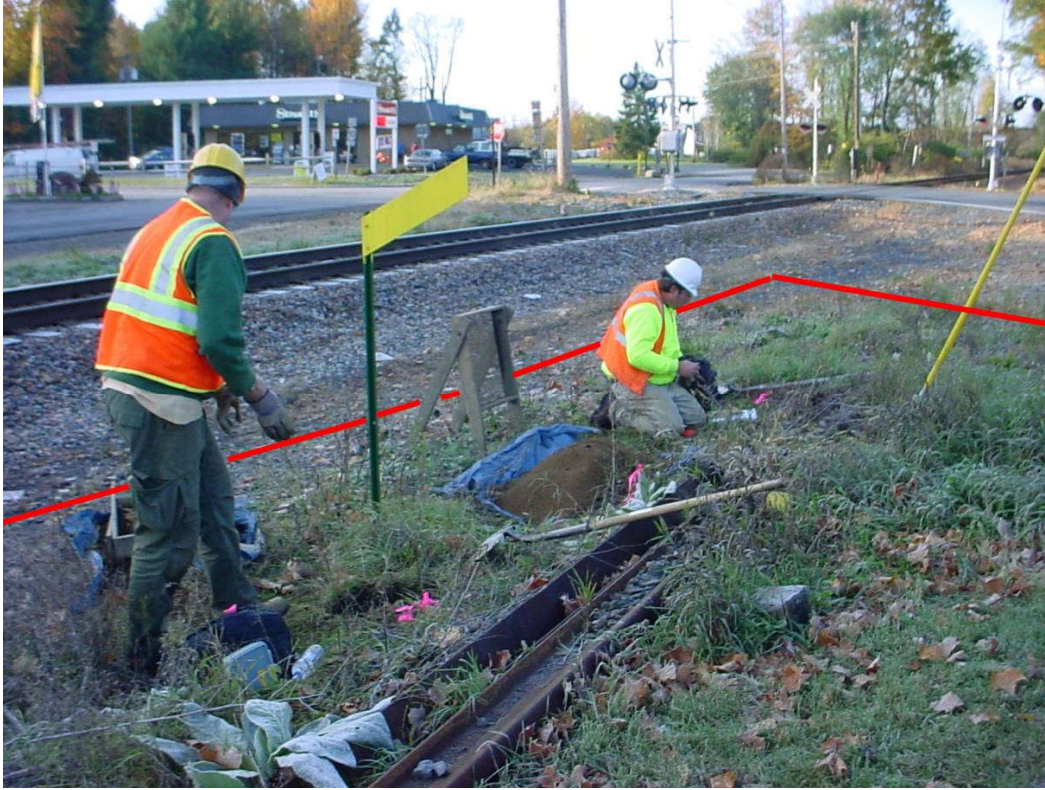
Photo 1. Archeologists working on Tests 5260 and 5259, from left to right, in Site 4 in Gansevoort. Two out-of-place metal rails lie in the foreground. The red line indicates the approximate limits of Site 4. View facing south.

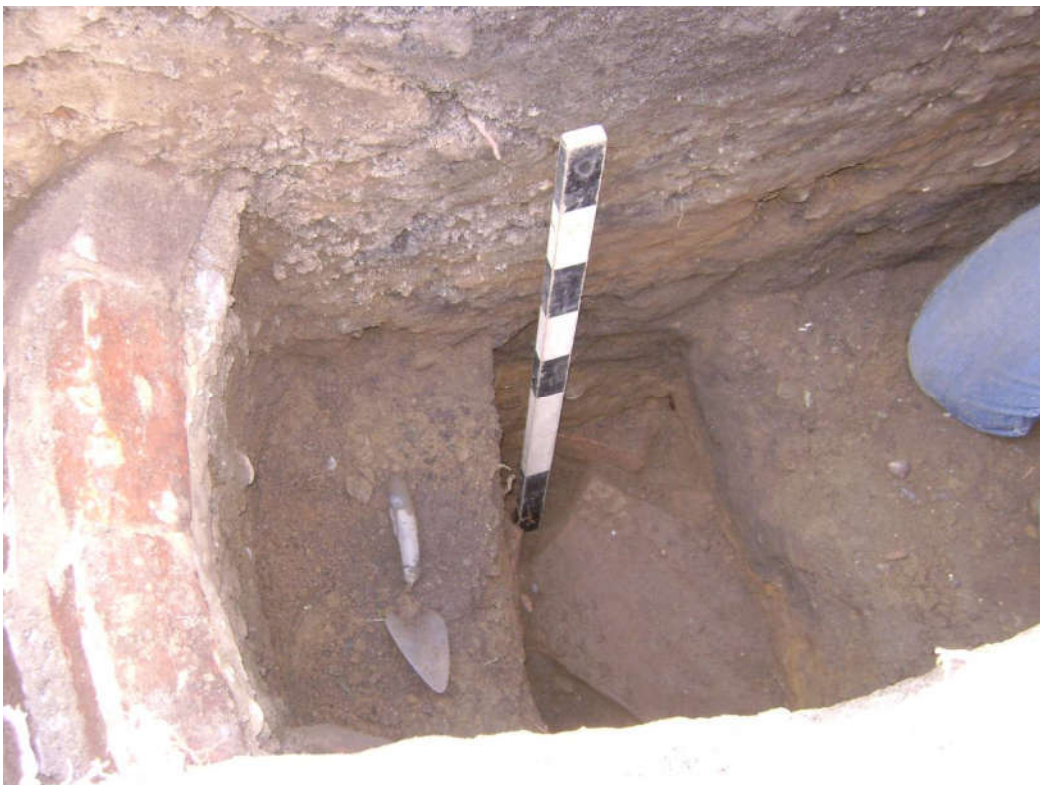
Photo 2. A view inside the brick cistern identified during the Phase II excavations at CHPE Site 4 in 2012.
