Segment 6-Package 4A

SITE PHOTOGRAPHS

Champlain Hudson Power Express

CHAMPLAIN HUDSON POWER EXPRESS SEGMENT 6 (PACKAGE 4A) - CP: BALLSTON TO GLENVILLE KIEWIT PROJECT NO. 21162 KC PROJECT NO. 120174 EROSION AND SEDIMENT CONTROL PLAN DRAWING NO. STA. 40000+00 TO STA. 40008+00 **C-401** 08/03/2023 OF AS NOTED DATE

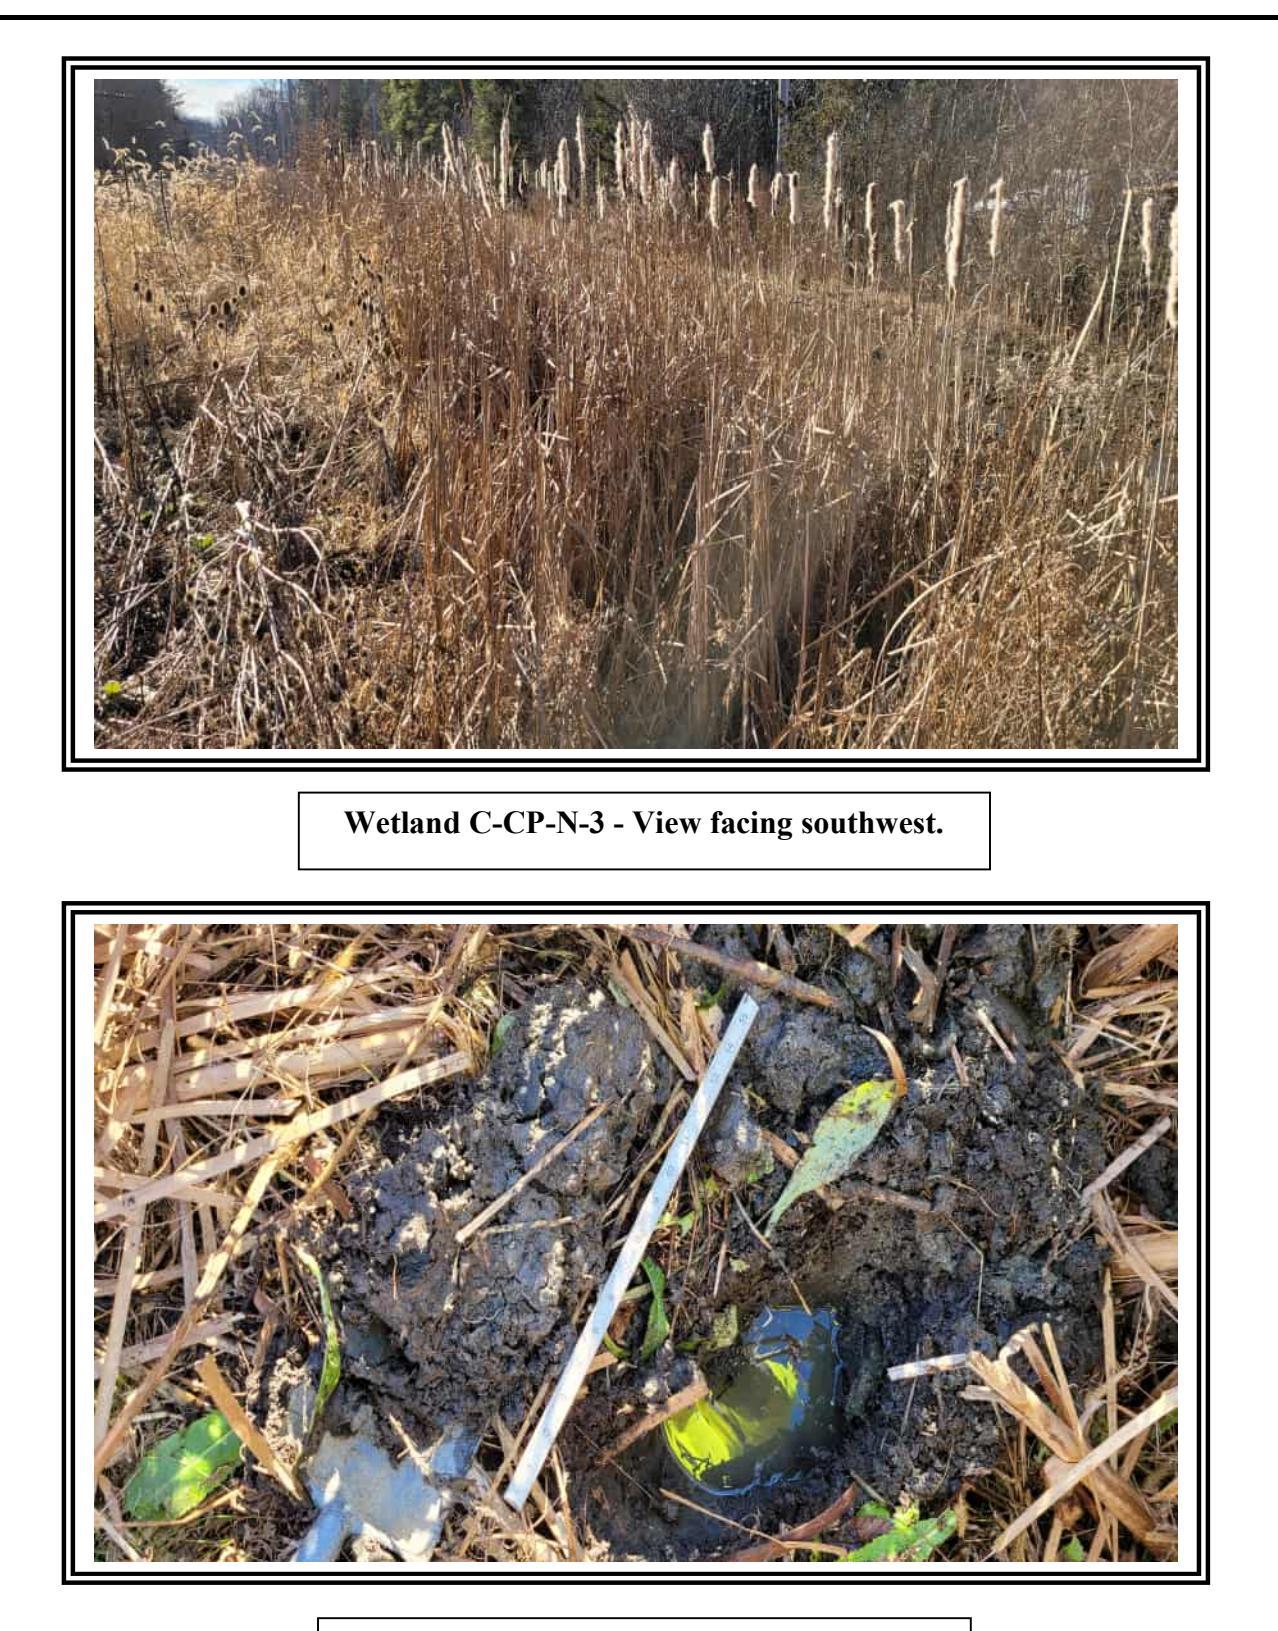
Wetland C-CP-N-3 - Soils

Profile Desc	cription: (Describe f	o the de	pth needed to docu	ument ti	he indica	ator or co	onfirm the absence of	f indicators.)
Depth	Matrix		Redox	x Featur	res			
(inches)	Color (moist)	%	Color (moist)	%	Type ¹	Loc ²	Texture	Remarks
0-7	10YR 2/1	93	10YR 5/3	5	C		Loamy/Clayey	Distinct redox concentrations

7.5YR 4/6	2	<u> </u>	pl		Prominent redox concentrations
7-16	10YR 2/1	65	7.5YR 4/6	25	с	pl	Loamy/Clayey	Prominent redox concentrations
			10YR 6/4	10	<u> </u>	pl		Prominent redox concentrations
¹ Type: C=C	oncentration, D=Depl	etion, RN	I=Reduced Matrix, N	/S=Mas	ked Sand	d Grains.	² Location: P	L=Pore Lining, M=Matrix.
Hydric Soil Indicators: Polyvalue Below Surface (S8) (LRR R, Histosol (A1) MLRA 149B) Black Histic (A3) Thin Dark Surface (S9) (LRR R, MLRA Hydrogen Sulfide (A4) High Chroma Sands (S11) (LRR K, L) Stratified Layers (A5) Loamy Mucky Mineral (F1) (LRR K, L) Depleted Below Dark Surface (A11) Loamy Gleyed Matrix (F2) Thick Dark Surface (A12) Depleted Matrix (F3) Sandy Mucky Mineral (S1) X Sandy Redox (S5) Redox Dark Surface (F6) Stripped Matrix (S6) Marl (F10) (LRR K, L) Dark Surface (S7) Sandy rophytic vegetation and wetland hydrology must be present, unless dis					LRR R, , MLRA ^A R K, L) R K, L) nless dist	2 cm Mu Coast Pr 149B) 5 cm Mu Polyvalu Thin Dar Iron-Man Piedmon Mesic Sp Red Para Very Sha Other (E	ick (A10) (LRR K, L, MLRA 149B) rairie Redox (A16) (LRR K, L, R) icky Peat or Peat (S3) (LRR K, L, R) the Below Surface (S8) (LRR K, L) the Surface (S9) (LRR K, L) the Surface (S9) (LRR K, L) the Floodplain Soils (F12) (LRR K, L, R) the Floodplain Soils (F19) (MLRA 149B) podic (TA6) (MLRA 144A, 145, 149B) ent Material (F21) allow Dark Surface (F22) the standard

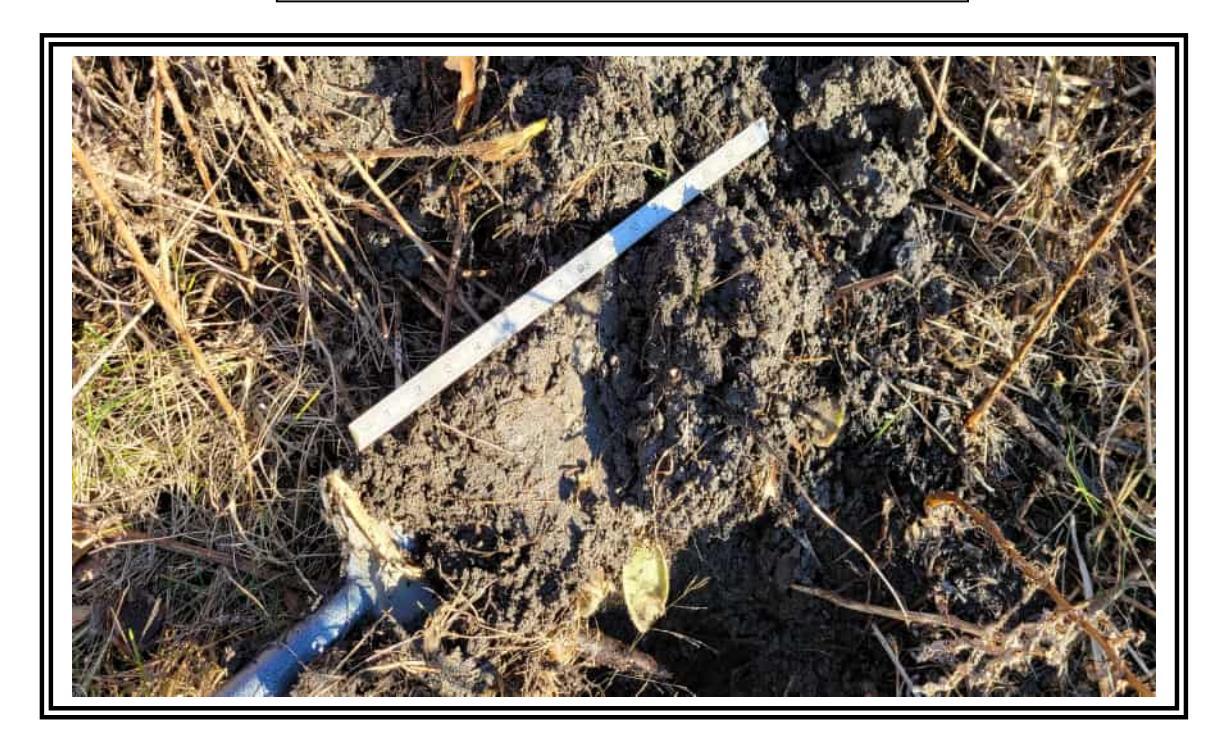
Upland C-CP-N-3 - Soils

Depth Matrix Redox Features (inches) Color (moist) % Color (moist) % Type ¹ Loc ² Texture F 0-13 10YR 2/1 100	Remarks
(Incres) Color (moist) % Color (moist) % Type Loc Texture r 0-13 10YR 2/1 100	
0-13 10YR 2/1 100 Loamy/Clayey 13-16 10YR 4/1 80 10YR 3/6 20 c m Loamy/Clayey Prominent re	edox concentrations
13-16 10YR 4/1 80 10YR 3/6 20 c m Loamy/Clayey Prominent n	edox concentrations
¹ Type: C-Concentration D-Depletion RM-Reduced Matrix MS-Masked Sand Grains ² Location: PL-Pore Lining /	M-Matrix
Hydric Soil Indicators:	Hydric Soils ³
Histosol (A1) Polyvalue Below Surface (S8) (LRR R. 2 cm Muck (A10) (LRR f.	K. L. MLRA 149B)
Histic Epipedon (A2) MLRA 149B) Coast Prairie Redox (A1	6) (LRR K. L. R)
Black Histic (A3) Thin Dark Surface (S9) (LRR R. MLRA 149B) 5 cm Mucky Peat or Pea	at (S3) (LRR K. L. R)
Hvdrogen Sulfide (A4) High Chroma Sands (S11) (LRR K. L) Polyvalue Below Surface	e (S8) (LRR K. L)
Stratified Lavers (A5) Loamy Mucky Mineral (F1) (LRR K. L) Thin Dark Surface (S9) ((LRR K. L)
