Appendix 3-B: Justification for Centerline and Allowed Deviation Zone Excursions

Champlain Hudson Power Express Case 10-T-0139 Segment 18B EM&CP

Justification for Centerline and Allowed Deviation Zone Excursions

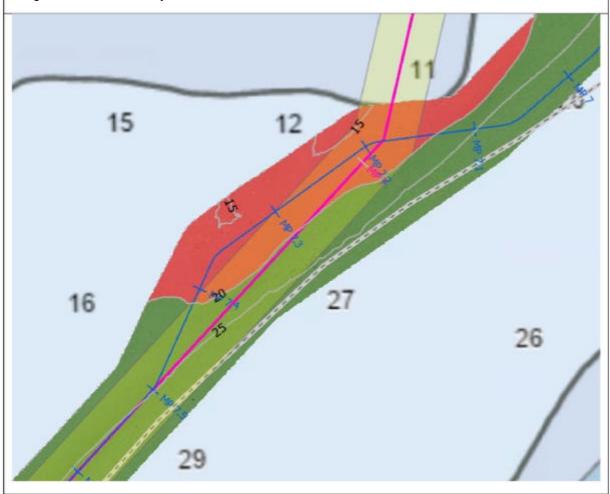
Figure 2-4 LC#D3 @ Point au Fer – Reynolds Point

ID:	LC#D3		
Location	MP Start	MP End	Length (Miles)
Lake Champlain	7.14	7.41	0.0

Image: Point au Fer – Reynolds Point

Small deviation into shallower water to avoid steep side slope to the east / southeast of the permitted route. Also, the geophysical survey shows till, which is hard to plow through. These engineering limitations justify this deviation.

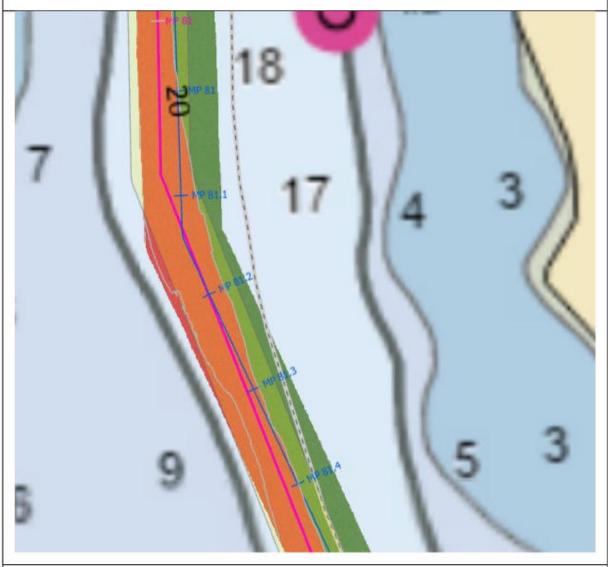
Figure 2-8 LC#D7 @ Miller Marsh

ID:	LC#D7				
Location	MP Start	MP End	Length (Miles)		
Lake Champlain	81.0	81.4	0.4

Image: Miller Marsh

Routing is located in the deepest available water on the New York side of the State border. No deeper water for alternative routing available.
